2016 ARCSEES DATA REPORT

SNOW, THAW, TEMPERATURE, AND PERMAFROST BOREHOLE DATA
FROM THE COLLEEN & AIRPORT SITES, PRUDHOE BAY, AND PHOTOS OF
QUINTILLION FIBER OPTIC CABLE IMPACTS, NORTH SLOPE, ALASKA

AGC 18-01

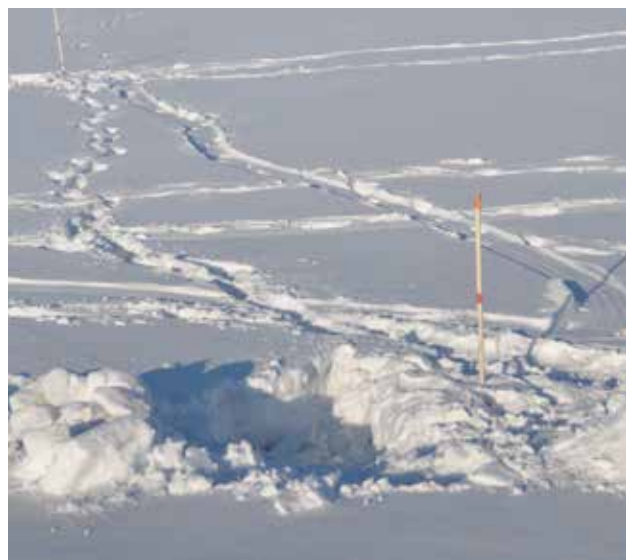
Figure 2.1. Measuring snow depths, snow density, and describing snow pits at permanent plots along Transect 4 on 28 March. Vertical PVC posts with red stripes mark the location of the permanent plots at 5, 10, 25, 50, and 100-m intervals along the transect. Photo: DSC 8801.

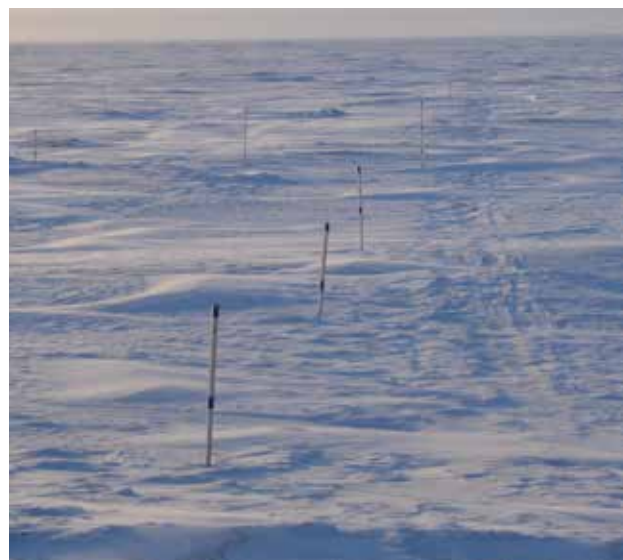
Figure 2.2. A night of strong winds altered the microtopography of the snow surface. On 31 March, Transect 4 had a rough surface with small dunes 10–20 cm deep. Note the difference from the relatively smooth surface of the undisturbed areas of snow in Figure 2.1. Photo: DSC 8892.

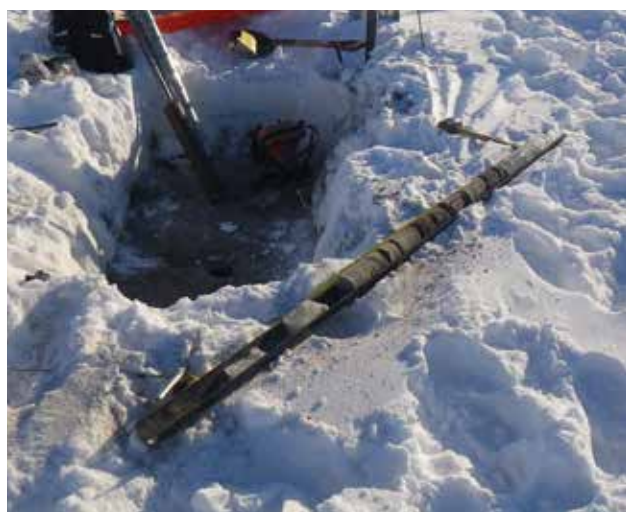
Figure 2.4. Core removed from Pond Marcel, 74.0 m from the road on Transect 1, Colleen Site A. Photo: IMG7710.

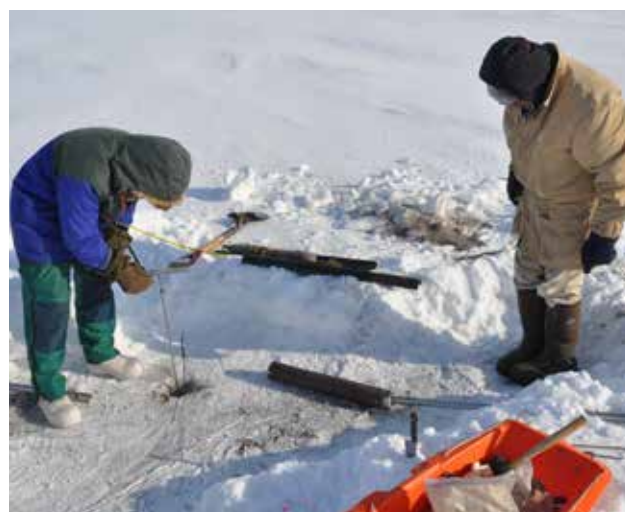
Figure 2.5. Borehole in thermokarst pond, Transect 5, Airport site. Photo: DSC 8706.

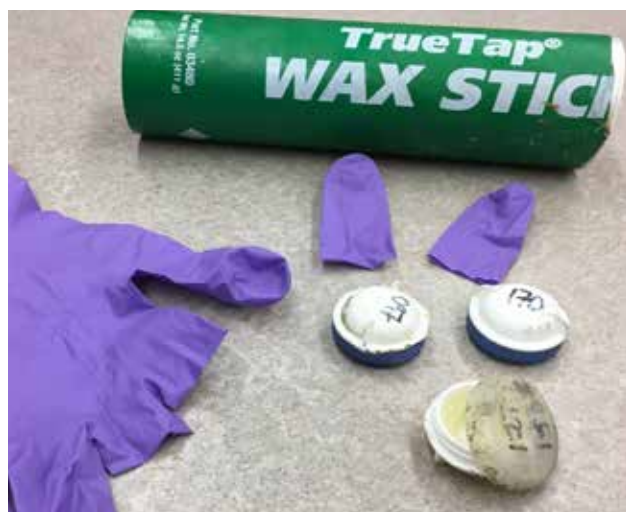
Figure 2.7. Tube wax, rubber gloves and contact lens cases purchased at the Prudhoe Bay General Store were used to keep temperature loggers drier in the field. Failure rates were lowest when iButtons were coated in the soft wax before being placed in the cut off finger of a Nitrile rubber glove, which was then knotted and placed in a small plastic bag. Photo: IMG 5519.

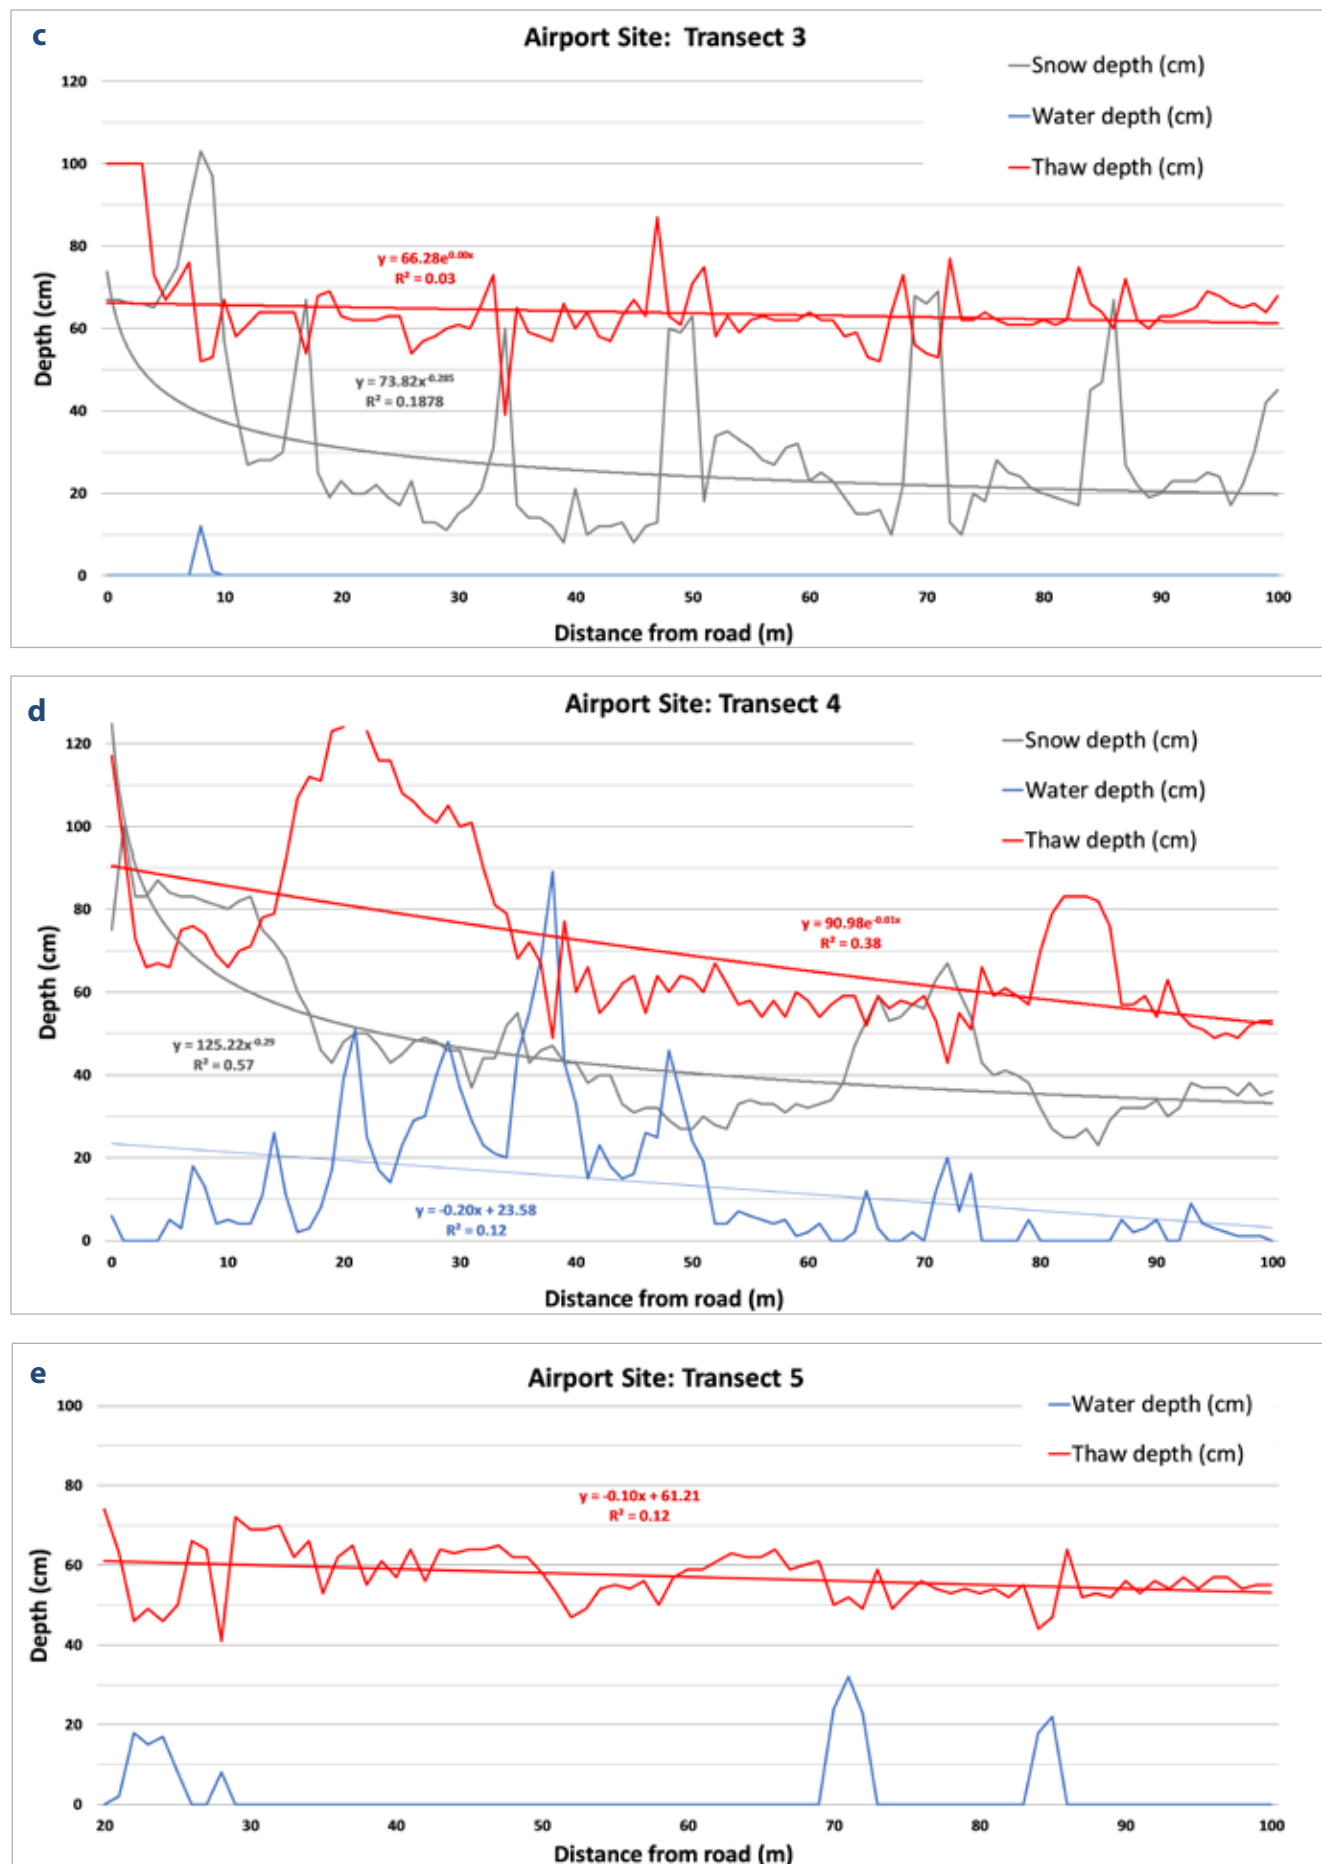
Figure 3.2. Trends in snow, water, and thaw depth with distance from the road along the four transects separated dry, moist, wet and aquatic vegetation types, showing trends of shallower snow and thaw depths in most vegetation types with distance from the road, largely due to the drifts on both sides of the road. Transect 5 is not included because no transect measurements of snow were taken along this transect.

Figure 3.2 shows trends in snow, water, and thaw depth for each transect grouped by vegetation moisture category (dry & barren, moist, wet, and aquatic). This also groups the points into broad microtopographic categories: The dry sites correspond to the highest microsites (dry high-centered polygons, and roadside margins); moist sites correspond mainly to well-drained polygon centers and low-centered rims; wet sites are mainly polygon troughs and wetter low-centered polygon basins; and aquatic sites correspond to the low microsites in polygon troughs. The plots that are broken out by moisture category primarily show weakly decreasing trends in thaw and snow depth with distance from the road and less point-to-point variation than the plots for the entire transects (Fig. 3.2).

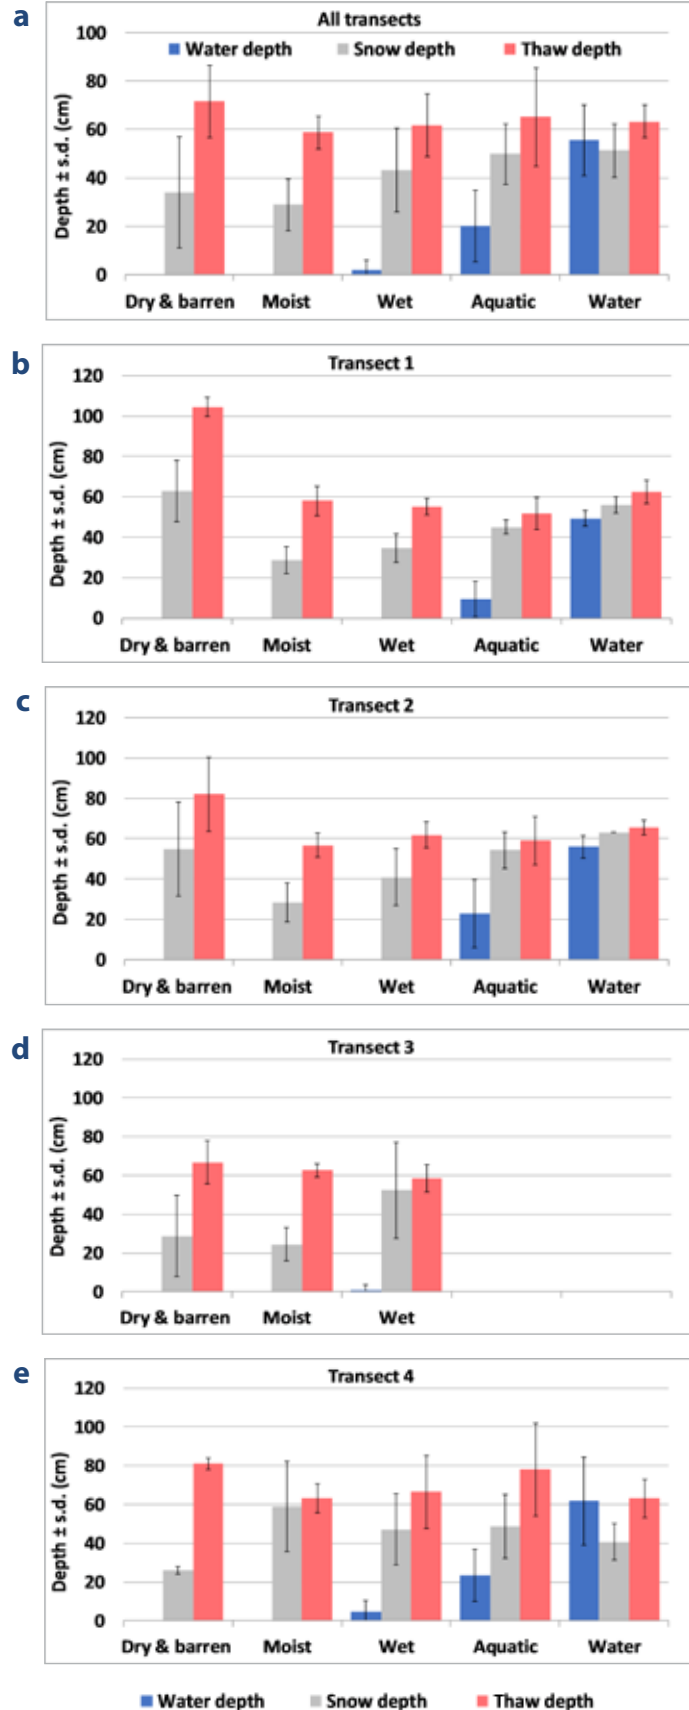
Figure 3.3. Mean snow, water, and thaw depth by vegetation moisture groups (a) across all transects and (b-e) by individual transect, T1–T4. Error bars are ± 1 standard deviation.

Downwind of the drifts, snow depths mainly varied in association with ice-wedge-polygon microtopography (Fig. 3.3). For all transects combined, the deepest snow occurs in the sites with ponded water (51 ± 11 cm), and the shallowest snow occurs in

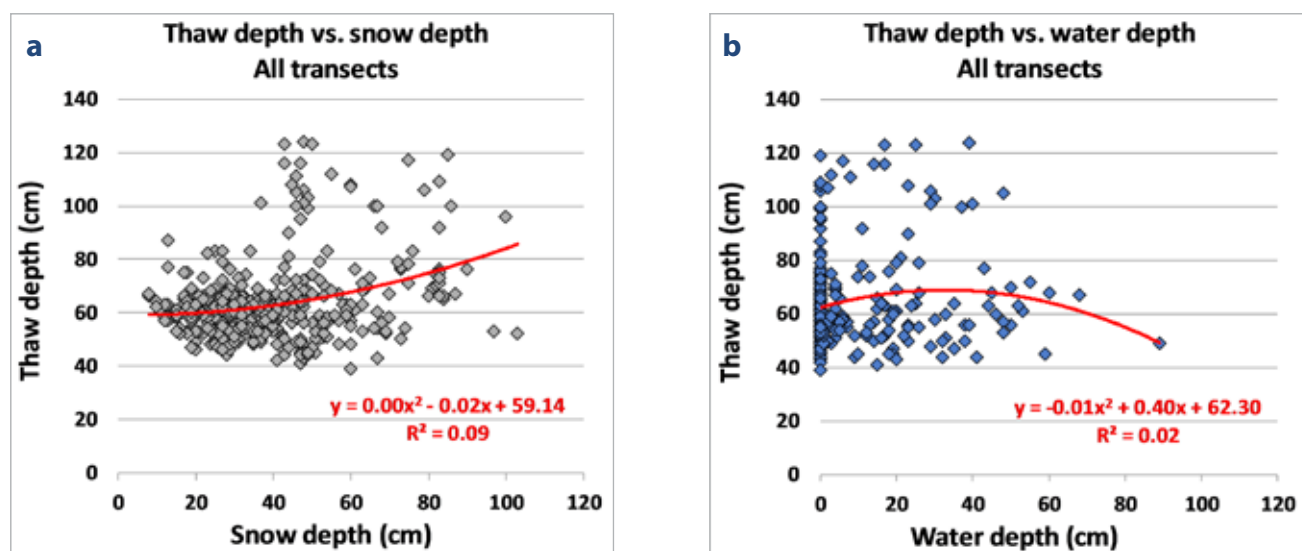
Figure 3.4. Thaw depth vs. (a) snow depth and (b) water depth at all points on Transects 1, 2, 3, and 4.

Thaw depth. Overall, thaw depths show weak curvilinear trend with snow depth, and a very weak linear trend with water depth (Fig. 3.4). As with snow depths, thaw depths along all transects show high point-to-point variations due mainly to variations in microtopographic relief and moisture status of the soils associated with ice-wedge polygon troughs, centers, rims, and thermokarst ponds (Fig. 3.1). When grouped by moisture categories and all transects, thaw depths were greatest in the dry & barren sites and shallowest in the moist sites (Fig. 3.3a). The dry and barren category included sites in deep drifts adjacent to the roads, and dry tundra areas further downwind with shallow snow. Transect 3 consisted of well-developed high-centered polygons with shallow snow (29 ± 21 cm deep) on the dry polygon centers and deep snow (52 ± 25 cm deep) in the troughs (Fig. 3.3d). Transect 4 had the most disturbed vegetation caused by a variety of factors including roadside drifting, flooding, and displaced gravel, which resulted in the overall deepest snow, water, and thaw of the five transects (Fig. 3.3e). Along Transect 4, a large area of gravel displaced by a road washout from a previous flood was classed as barren and had relatively shallow snow (23–30 cm). Transect 4 had patterns of snow and thaw depth that were most variable within moisture categories.

Water depth. Water might be expected to be somewhat deeper near the roads on flooded sides of the road, but the trends for water depth vs. distance from the road for the flooded Transects 2 and 4 are very weak and are controlled mainly by the position of water-filled troughs along the transects (Fig. 3.1b, d). When grouped by moisture categories, as expected, the deepest water occurs in the unvegetated-water microsites (56 ± 15 cm), followed by aquatic vegetation sites (20 ± 15 cm), and wet vegetation (2 ± 4 cm). The entire set of thaw-depth measurements shows a weak positive nonlinear trend with snow depth (Fig. 3.4a) and essentially no trend with water depth (Fig. 3.4b).

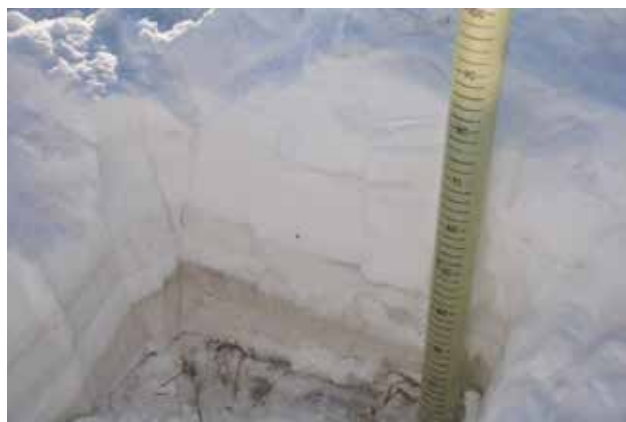
Figure 3.6. Snow pit at plot T2-005-T (Colleen Site A, Transect 2, 5 meters from road, polygon trough). Note the overall deep snow (97 cm), brown layers of dirty snow caused by road dust, several layers of high-density wind-packed snow, a thin hard layer at 8–19 cm (probably caused by a rain-on-snow event), and the dirty depth-hoar layer at the base of the snowpack. See profile in Appendix B. Photo: DSC 8811.

Photos of the snow pits at each plot reveal some of the major differences in snow of the dusty roadside drifts (Fig. 3.6), compared to the relatively clean snow in mesic tundra sites far downwind of the road (Fig. 3.7). Snow in the roadside drifts is characterized by numerous dirty layers caused by road dust. Winds are predominantly from the ENE at Prudhoe Bay, so the dust is most conspicuous in snow drifts on the west side of the roads (Fig. 3.8). Photos from all snow pits are in Appendix B, along with descriptions of snow pits at plots T1-200-T, T2-005-C, T2-005-T, T2-200-C, T2-200-T, and T5-025-C, and T5-025-T.

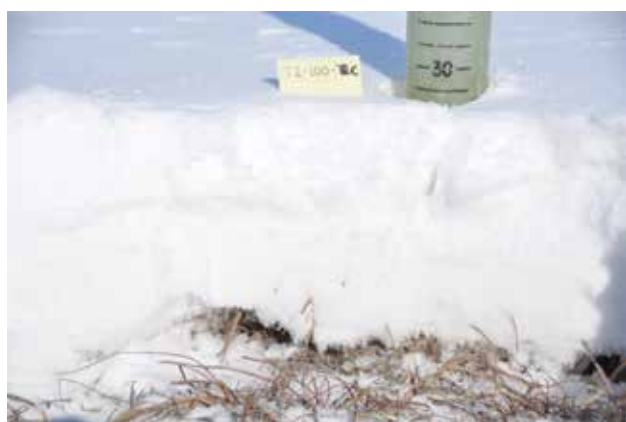
Figure 3.7. Snow pit at plot T2-200-C (Colleen Site A, Transect 2, 200 meters from road, polygon center). Note shallow snow depth (28 cm), overall clean snow, and clean depth-hoar layer. The thin hard layer at 10–11 cm corresponds to the layer at 18–19 cm in Fig. 3.6. See snow profile in Appendix B. Photo: DSC 8858.

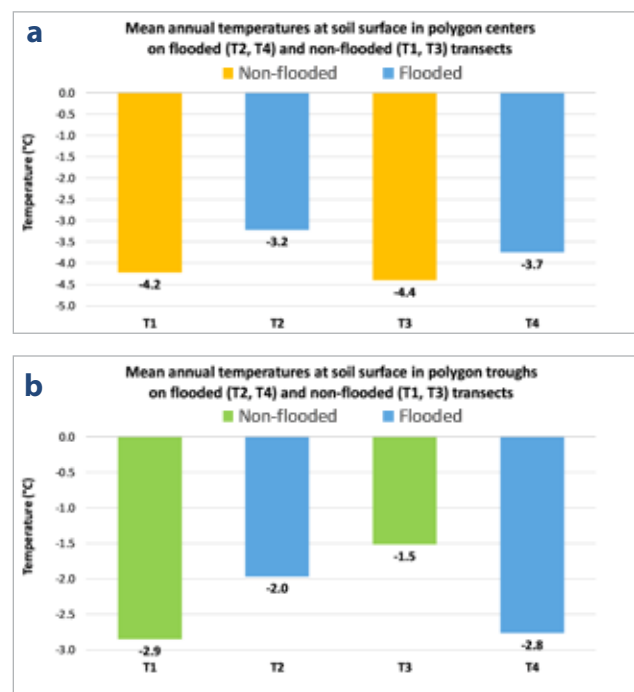
Figure 3.11. Mean annual surface temperatures in (a) polygon centers and (b) troughs on flooded (T2 and T4) vs. non-flooded transects (T1 and T3), July 2015–July 2016.

The temperature contrasts between polygon centers and troughs is best illustrated along Transect 3, where the warmest winter temperatures (Fig. 3.11 b) were due to deep snow in many of the polygon troughs. The deepest trough along all four transects was T3-10-T, which had a center-trough contrast of 1.16 m, 71 cm water depth in August 2016, 85 cm of snow in March 2016, and a mean annual temperature of $+0.3^{\circ}\text{C}$ at the soil-surface—the only point in the two study areas with a mean annual surface temperature above 0°C in 2015–2016. (Note: Trough depths were not measured directly but are represented by the

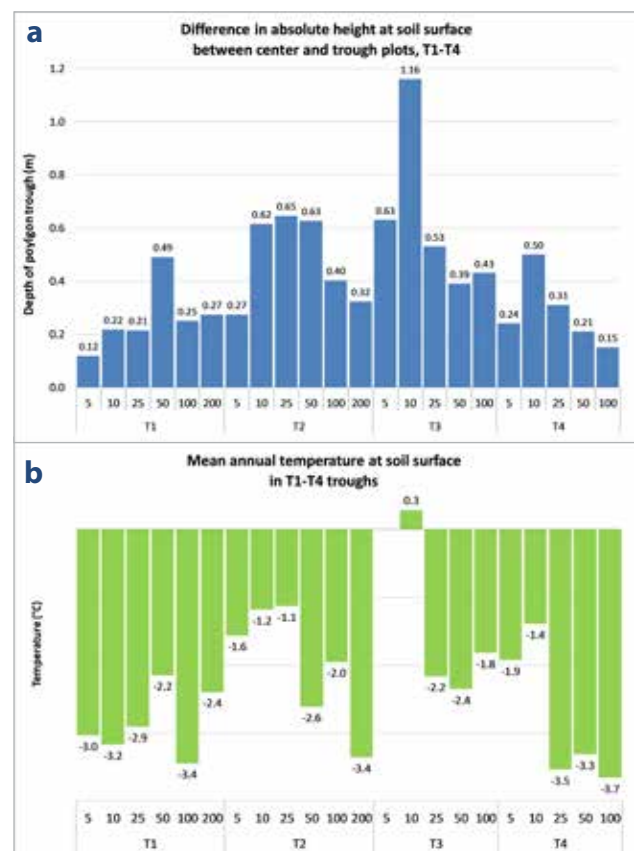
Figure 3.12. (a) Depth of polygon troughs and (b) mean annual surface temperatures in T1–T4 troughs, 2015–2016. Trough depth is measured by the difference in absolute height of vegetation plots established at polygon centers and troughs at the same distance from the road.

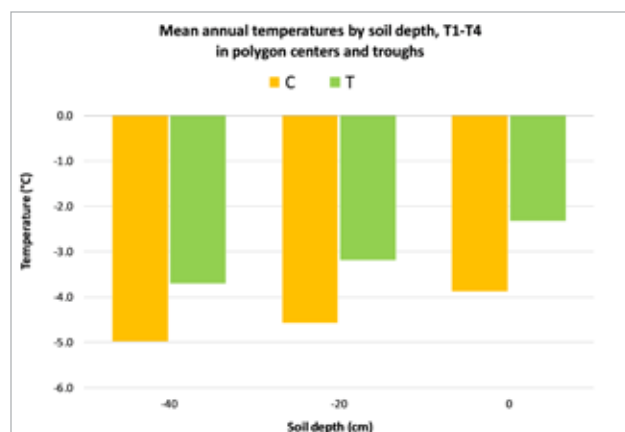
Figure 3.15. Mean annual temperatures decrease with soil depth on both polygon centers and troughs, but the difference between centers and troughs gets smaller with depth. The average difference across all transects (T1-T4) is -1.56°C at the soil surface, -1.38°C at -20 cm , and -1.28°C at -40 cm .

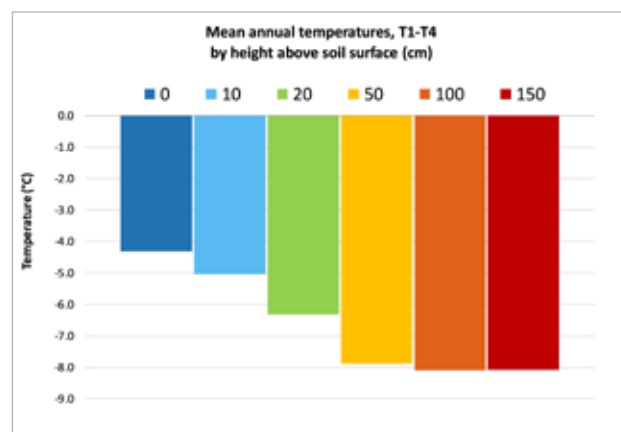
Figure 3.16. Mean annual air temperatures decrease with distance from the ground due primarily to winter snow accumulation. In 2015-2016, the snow pack moderated temperatures up to 50 cm from the ground. The MAT at the surface on T1-T4 was 3.8 degrees warmer than at 100 cm in the air.

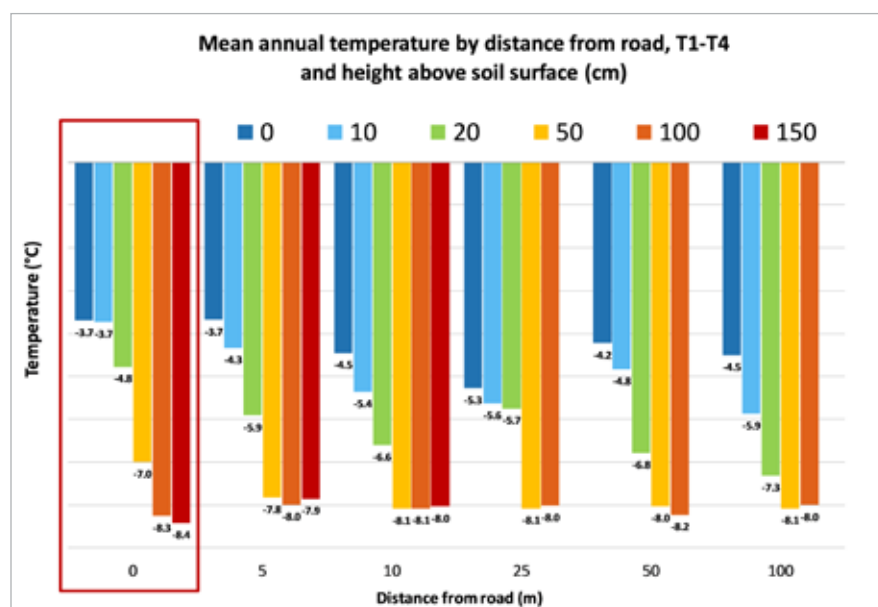
Figure 3.17. The difference in ground and air temperature is greatest at the road berm (where the snow pack is deepest) and decreases with height above surface and distance from the road. In 2015-2016, the mean annual surface temperature within 5 meters from the road was $0.5 - 1.6^{\circ}\text{C}$ higher than surface temperatures further from the road. The deeper snow pack at the road berm (red rectangle) insulated the air temperature up to 50 cm from the ground.

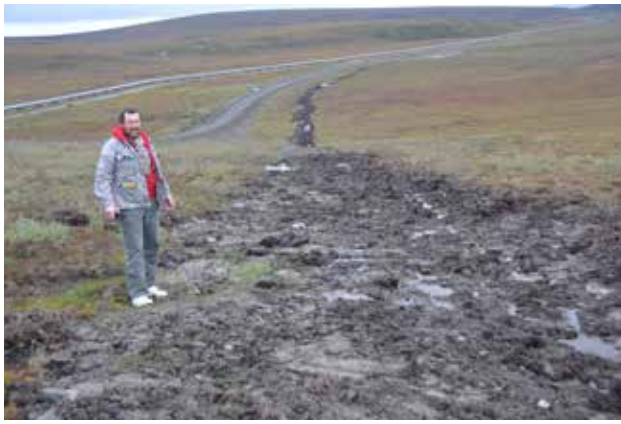
Figure 3.20. Severe tundra disturbance caused by placement of the Quintillion fiber optic cable in summer, near Milepost 305 of the Dalton Highway, 16 August 2016. The width of the damaged tundra in sections constructed in summer is approximately 8.5 m. Photo: DSC 9199.

The cable is buried in a trench dug during the summer and winter of 2015–2016 that resulted in severe disturbance to vegetation and permafrost along the highway corridor between Prudhoe Bay and Fairbanks (Fig. 3.20–3.22). The disturbances are especially noticeable in tundra environments north of the Brooks Range. During our August 2016 field trip, we took 100 photographs of some of the damage in the area from approximate Dalton Highway mileposts 300 to 355. Forty selected photos are included in Appendix C.

Photos of sections of the Quintillion fiber-optic-cable trench document damage to the tundra and permafrost (Appendix C). The damage is especially visible in tundra environments north of the Brooks Range. Severe damage occurred in the scenic Atigun Pass area and north through the Arctic Foothills (Fig. 3.20) and across the Arctic Coastal Plain. Removal of the vegetation mat and ponding of water is causing subsidence of the surface, which is especially severe in hilly areas such as the Sagwon Upland, where the trench has exposed massive ground ice to thermal erosion (Fig. 3.21).

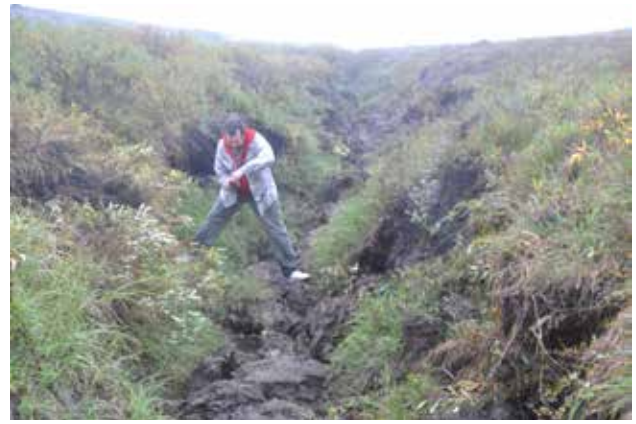
Figure 3.21. Thermokarst in the trench of the Quintillion fiber optic cable, Sagwon Upland, near Milepost 355 of the Dalton Highway, 16 August 2016. Photo: DSC 9275.

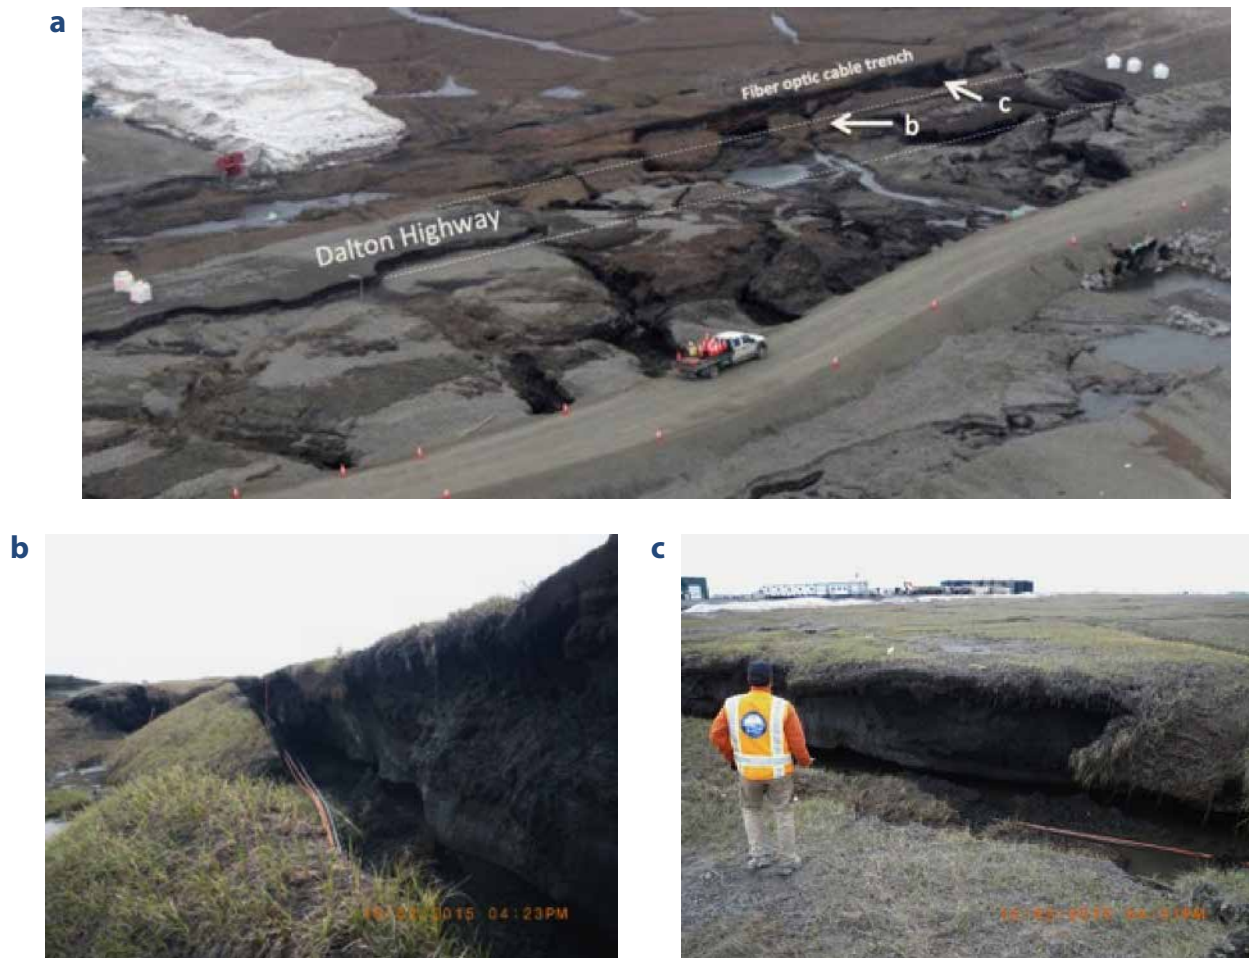
Figure 3.22 (a) Washed out section of the Dalton Highway near the Deadhorse Airport caused by the 2015 Sagavanirktok River flood. Floodwaters threatened the Deadhorse Airport runway (beyond the upper margin of the photo), and the highway acted as a dam preventing water from flowing away from the airport toward the Sagavanirktok River (lower right). When the road was breached to allow floodwaters to drain away from the airport, massive erosion of ice wedges occurred between the Quintillion fiber optic cable trench and the river. Approximate locations and directions of the photos in (b) and (c) are shown by the white arrows in photograph (a). Orange fiber optic cables are visible in all three frames. Photos courtesy of AK Department of Transportation & Public Facilities.

At the northern end of the Dalton Highway, the cable also played a role in the damage caused by the 2015 Sagavanirktok Flood. The cable trench formed the break point where the tundra developed massive erosion of ice wedges (Fig. 3.22).
