Living on Ice-rich Permafrost: 50 years to a slow-moving disaster in Point Lay, Alaska

Tribal Resilience Learning Network | April 19, 2023

2022 research activities, findings
and recommendations

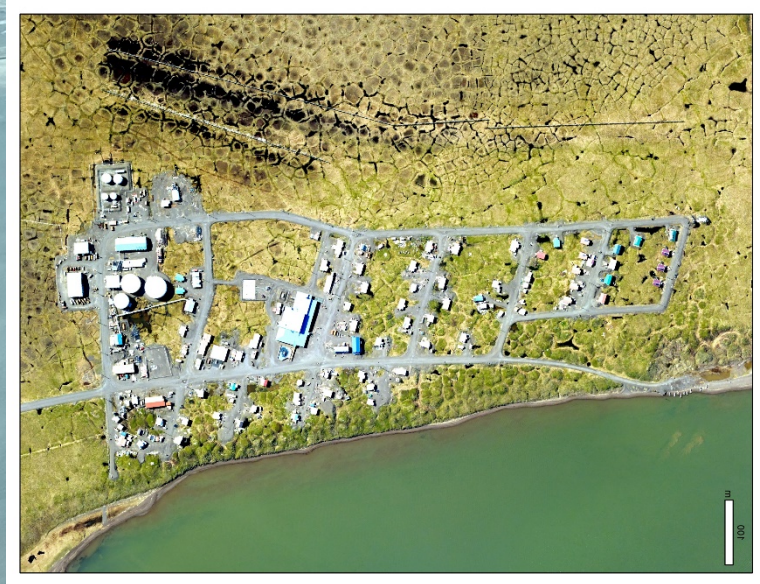
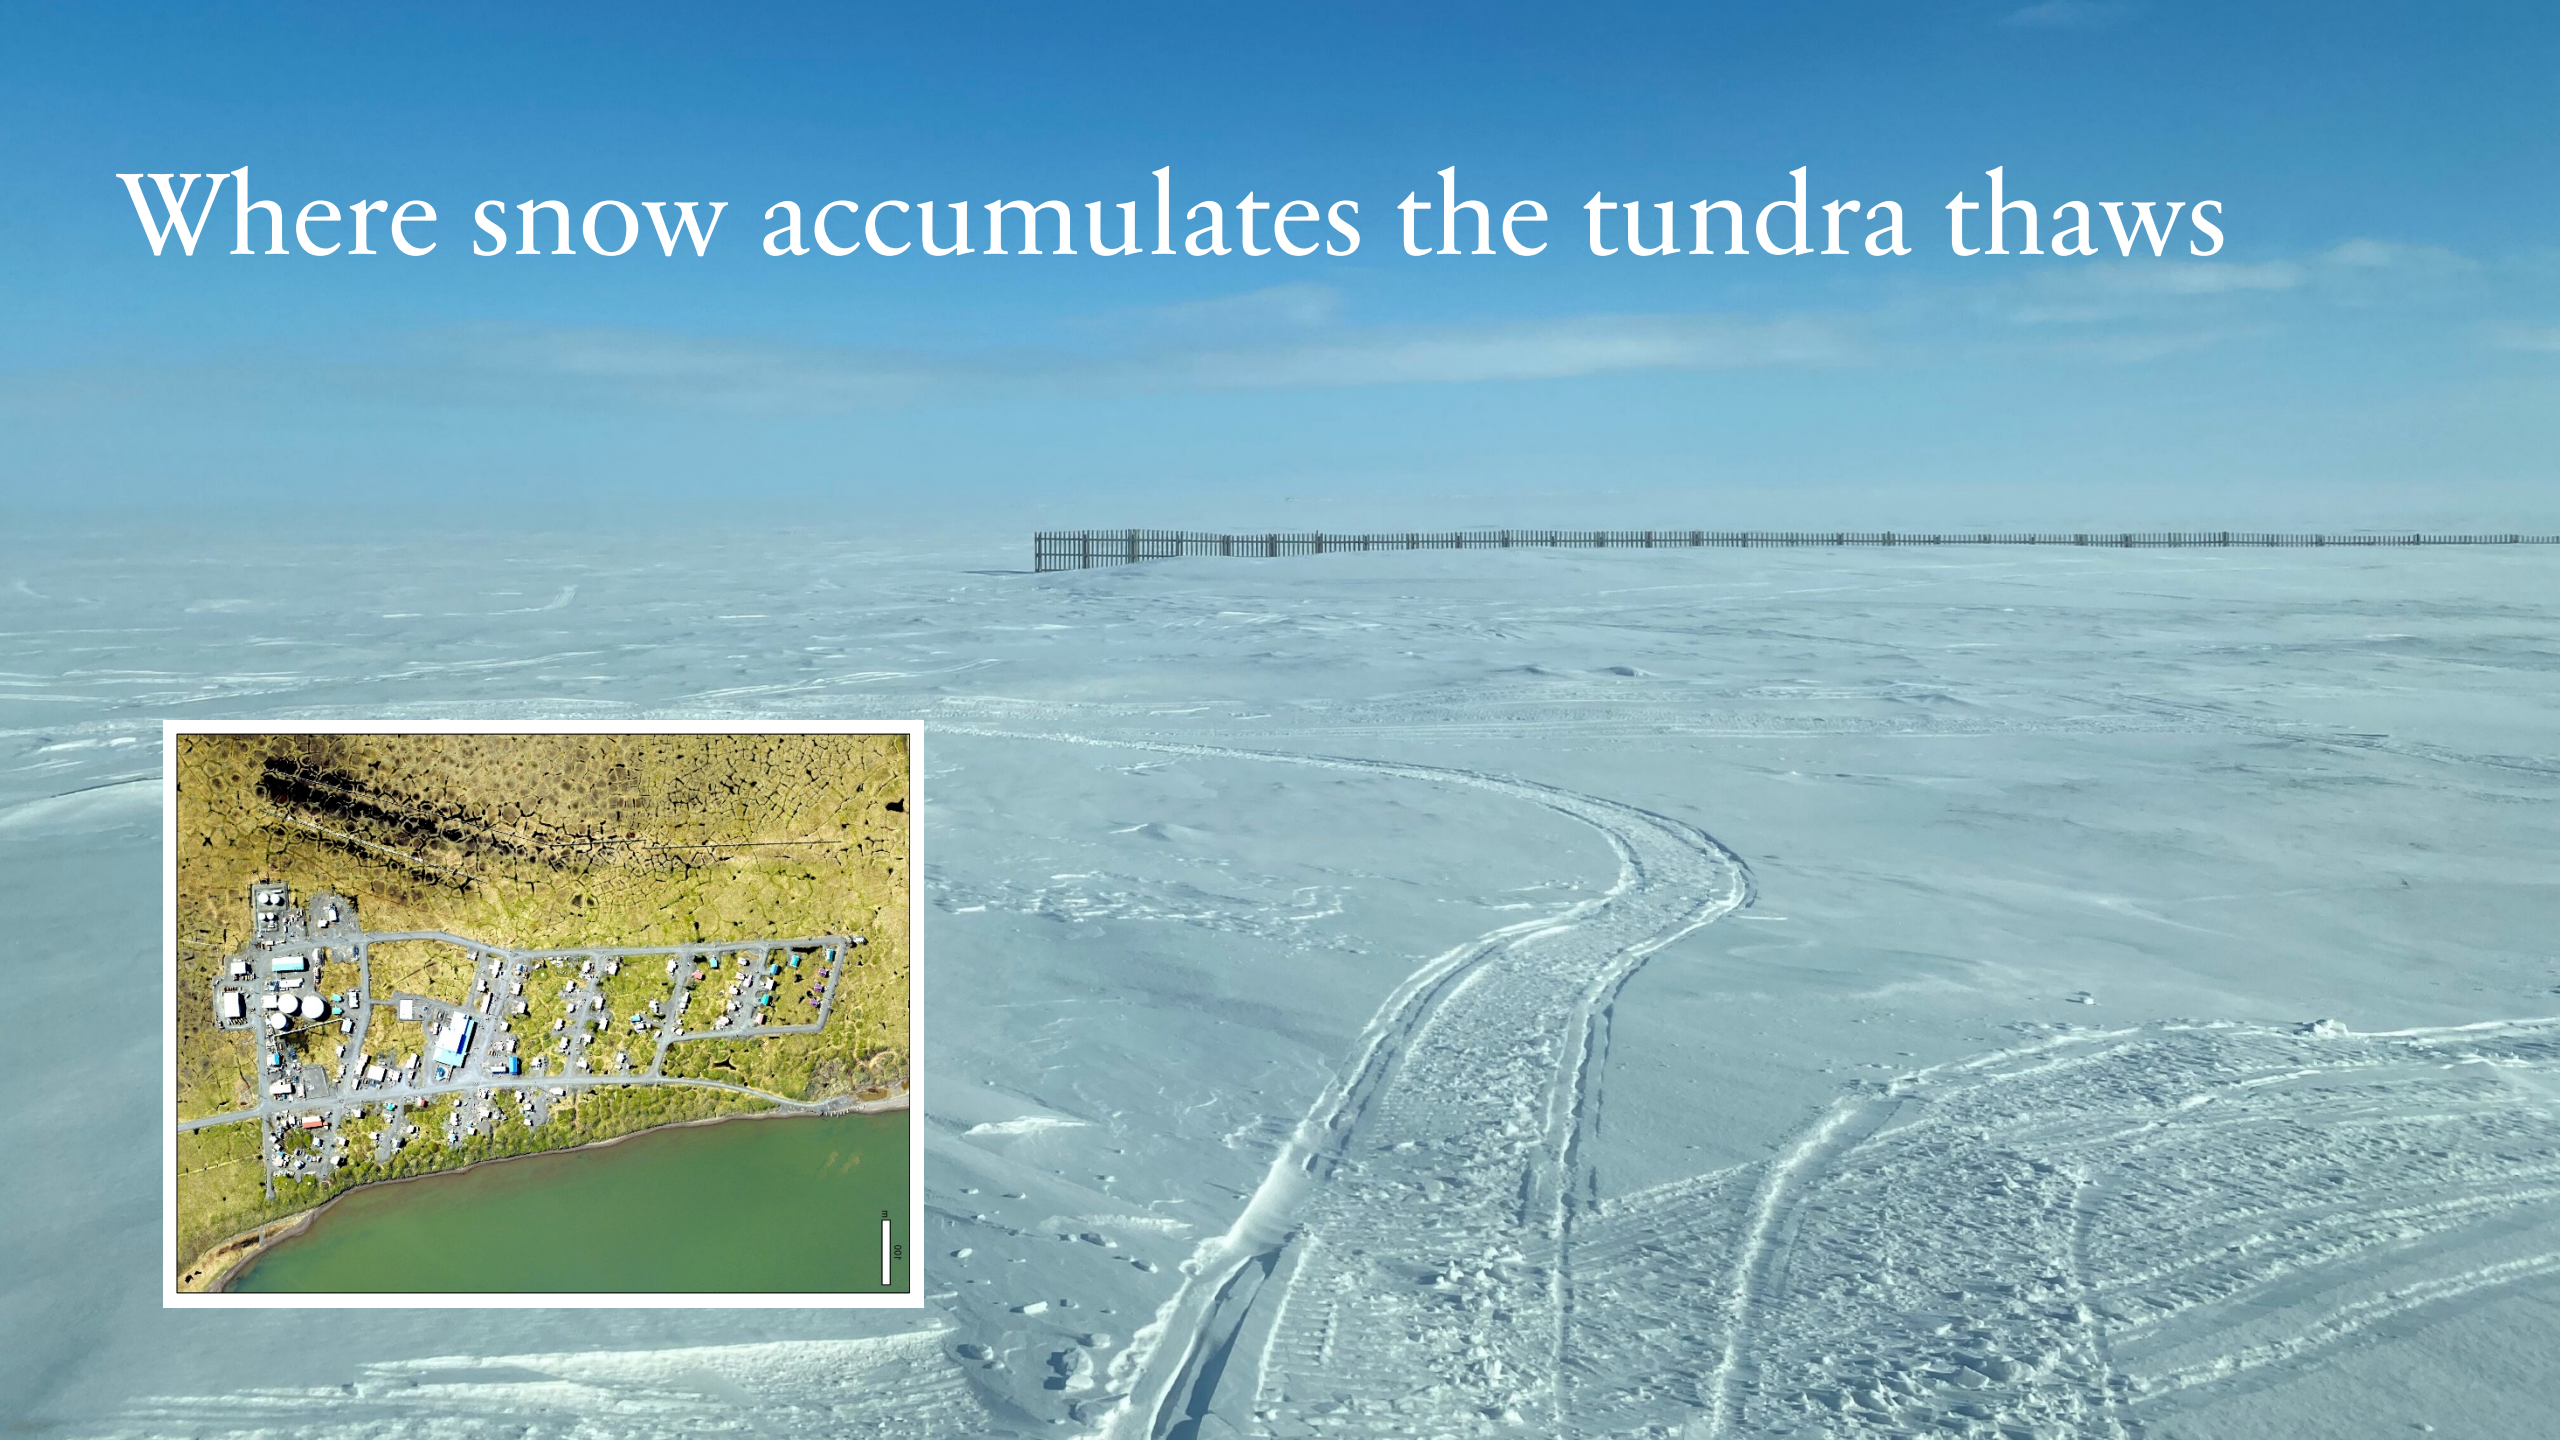
Where snow accumulates the tundra thaws

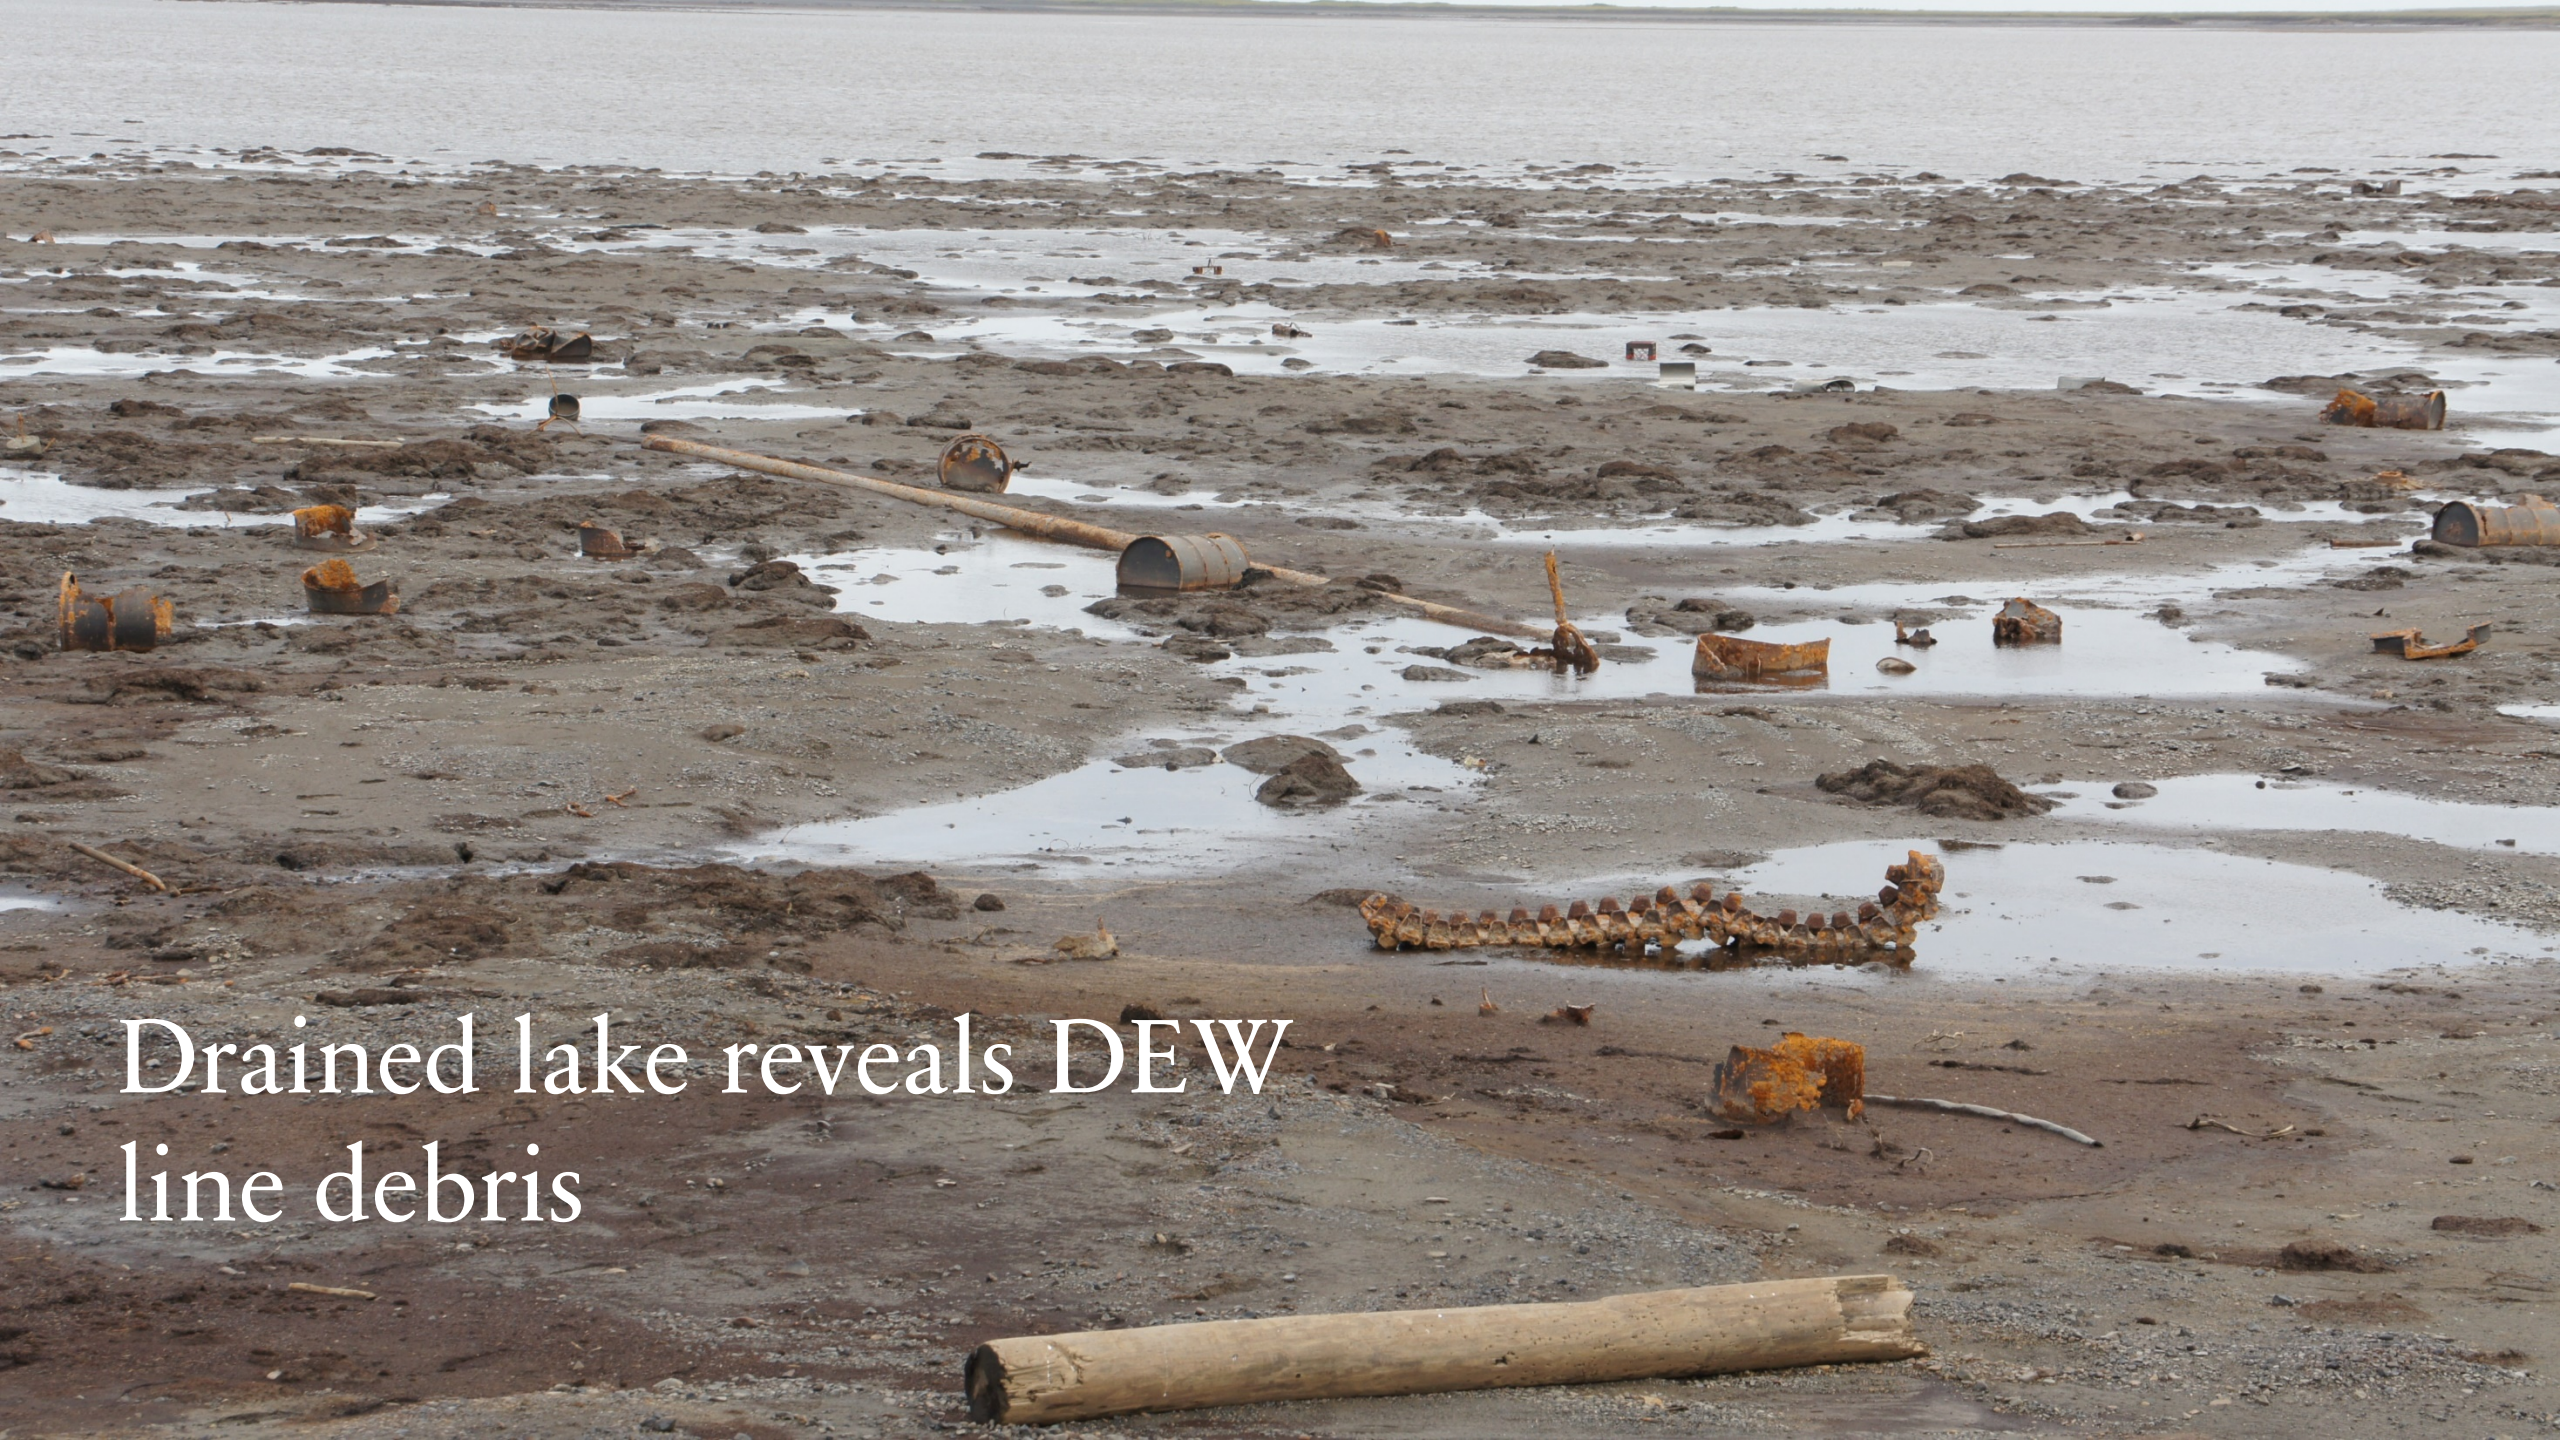
Loss of fresh water source due to permafrost thaw

Drained lake reveals DEW
line debris

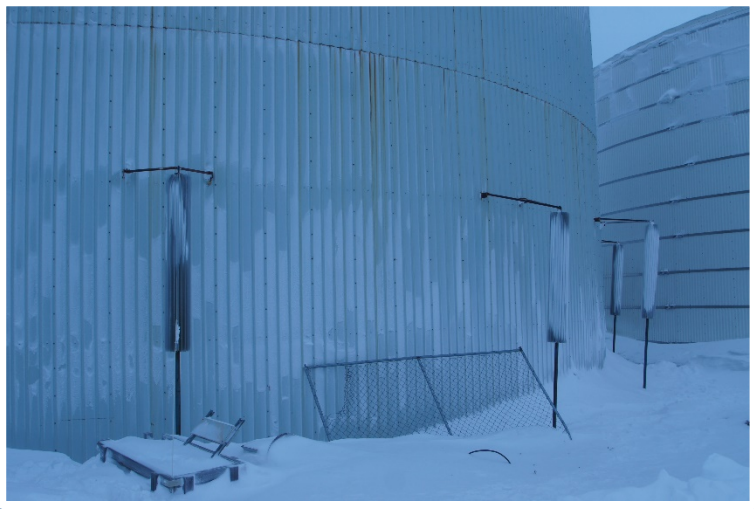
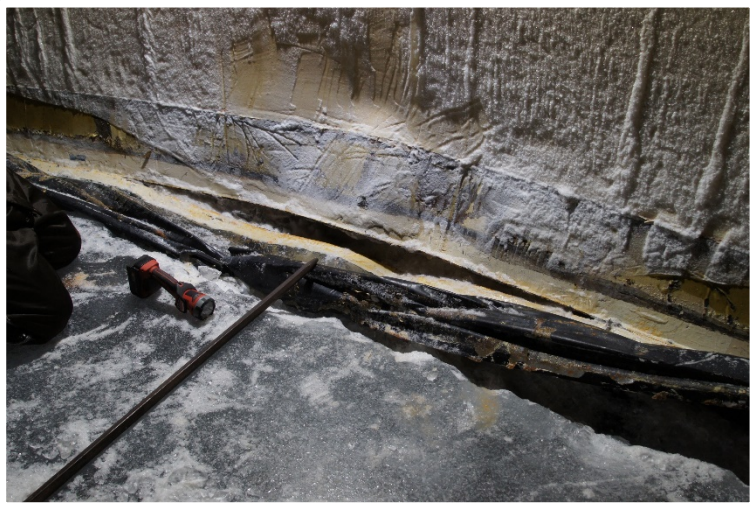
Water Storage tank failure

Lost 1 million gallon tank
due to unmonitored thermosiphon
failure and ground subsidence

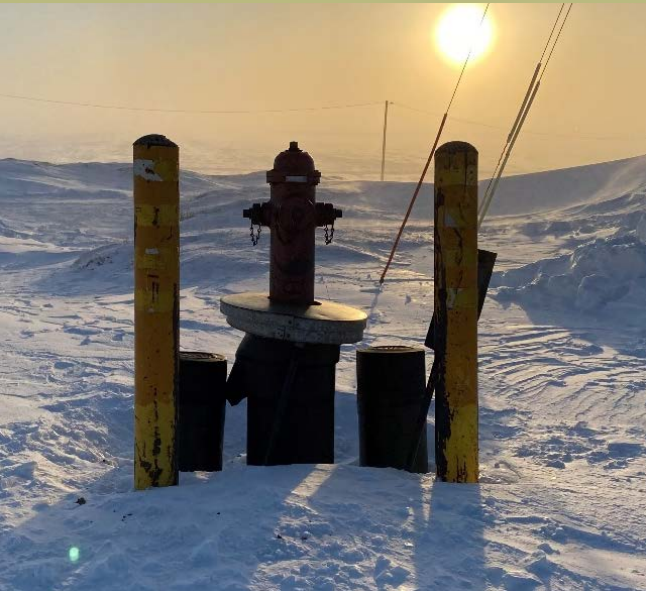
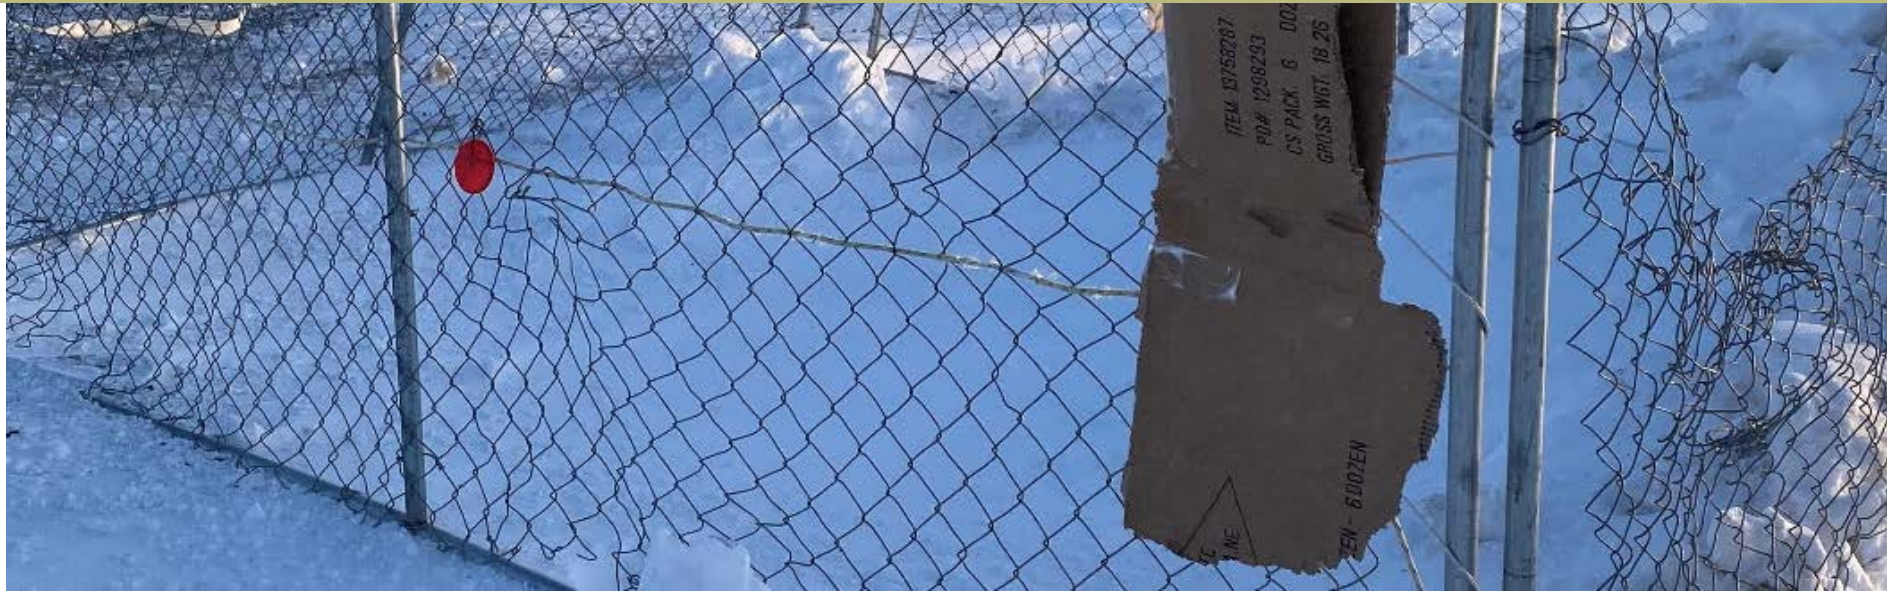
Water main ruptures / fire hydrant failure / sinkholes

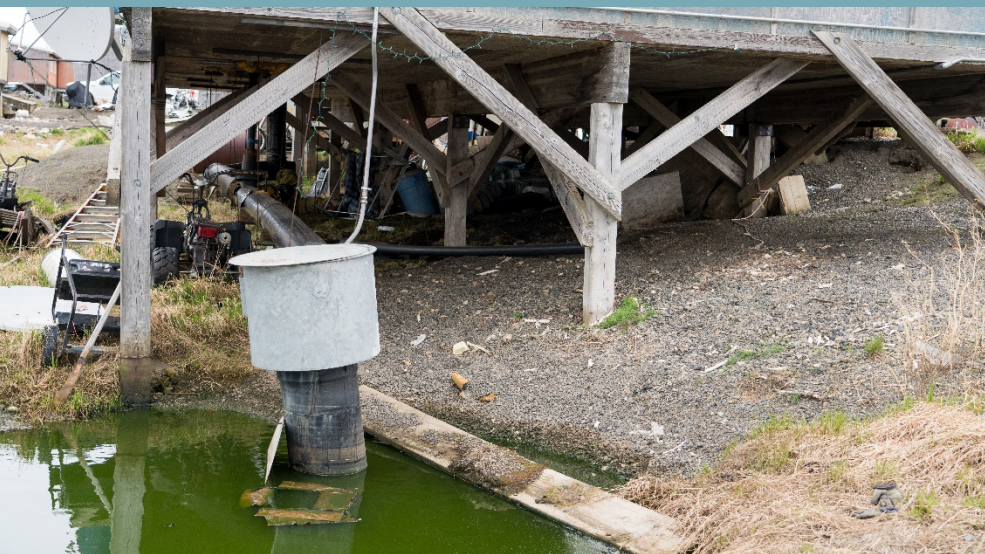
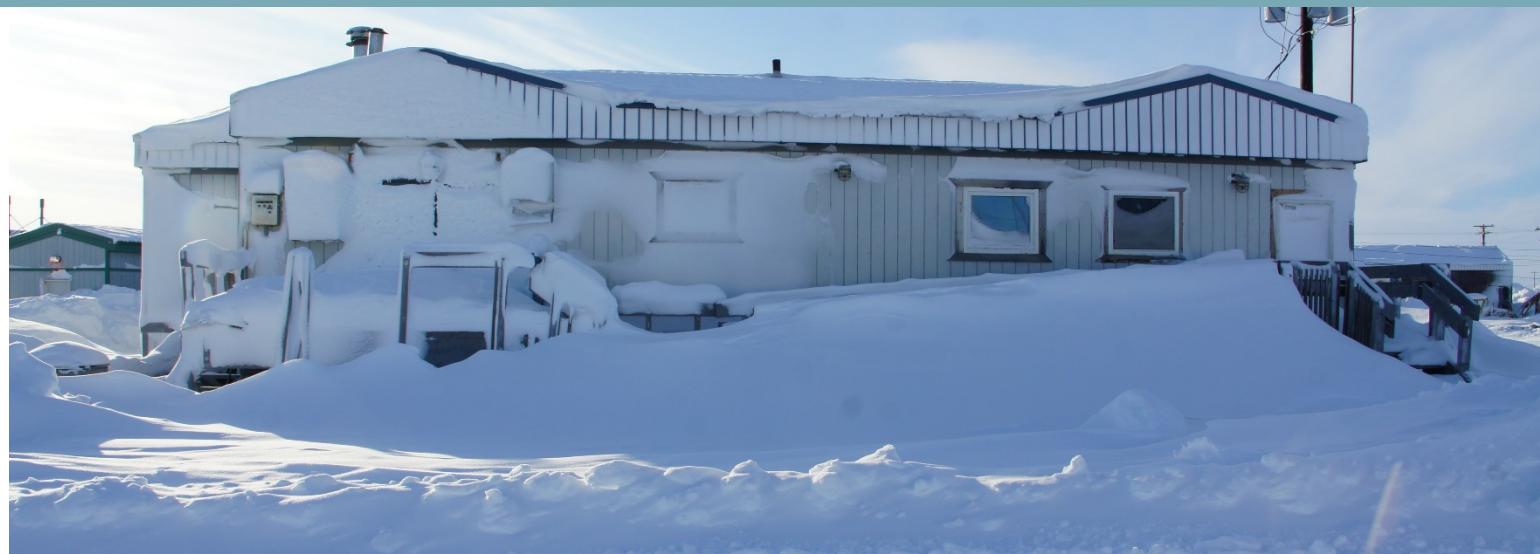
Water & sewer failures / abandoned homes, washeteria

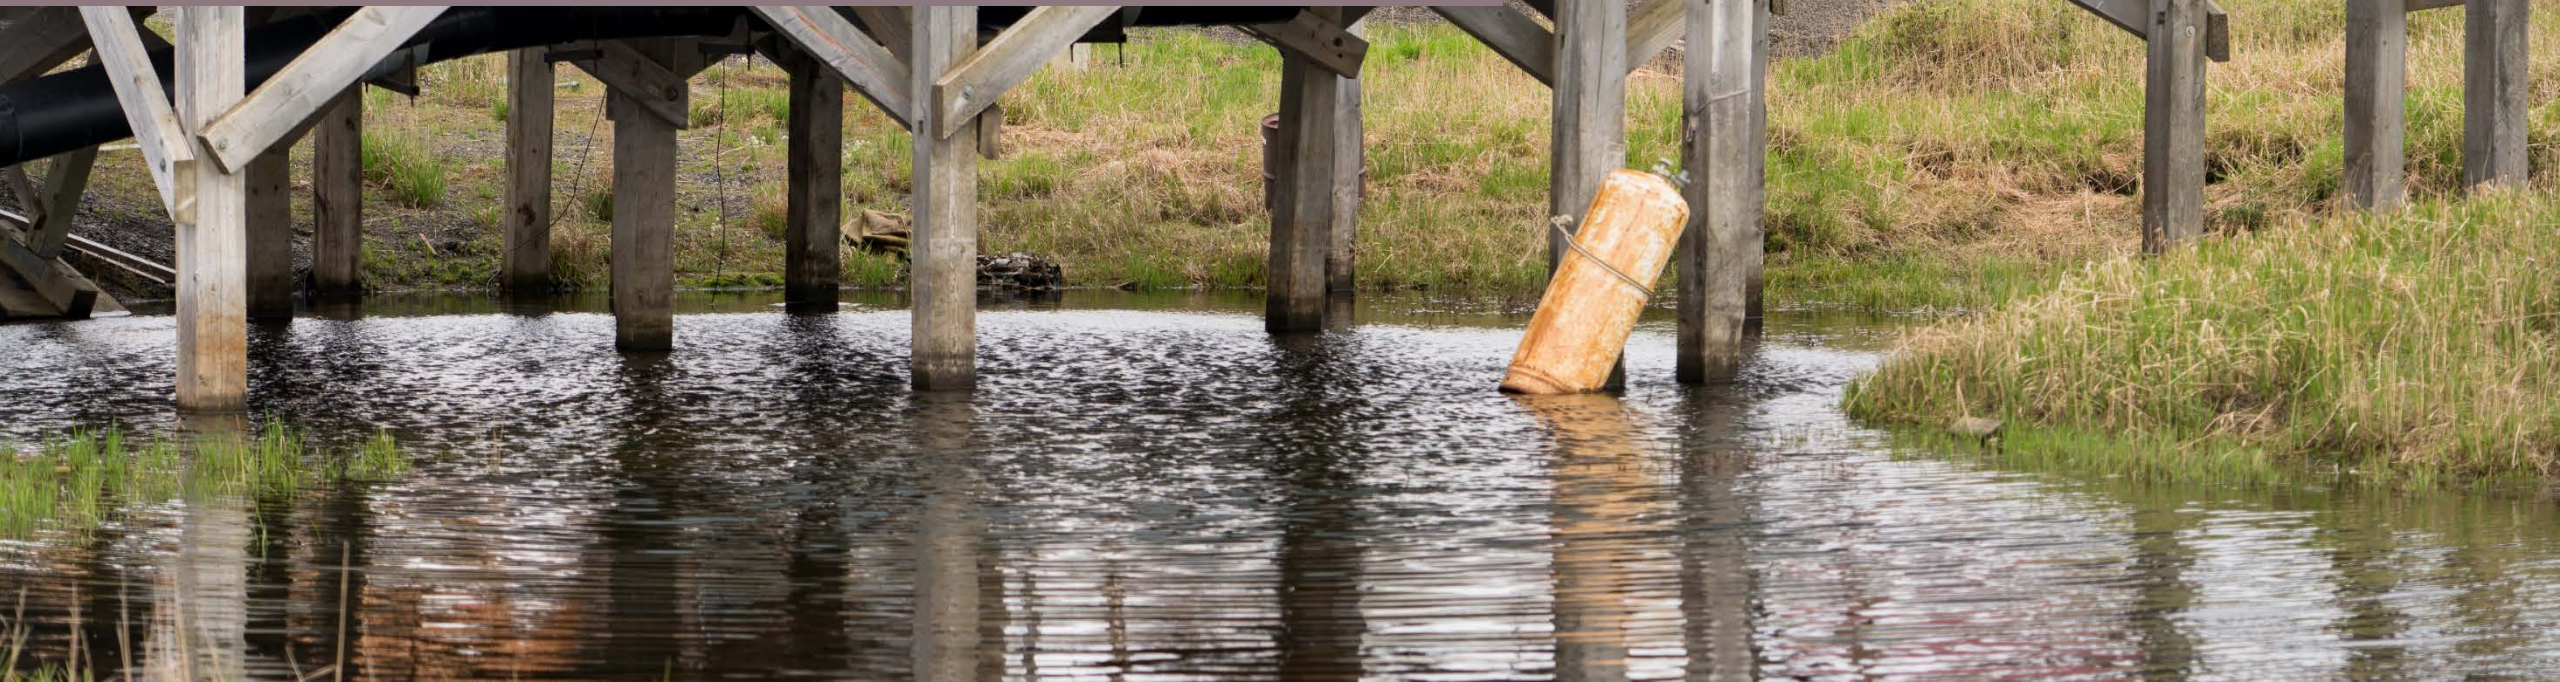
Thermokarst & Ponding

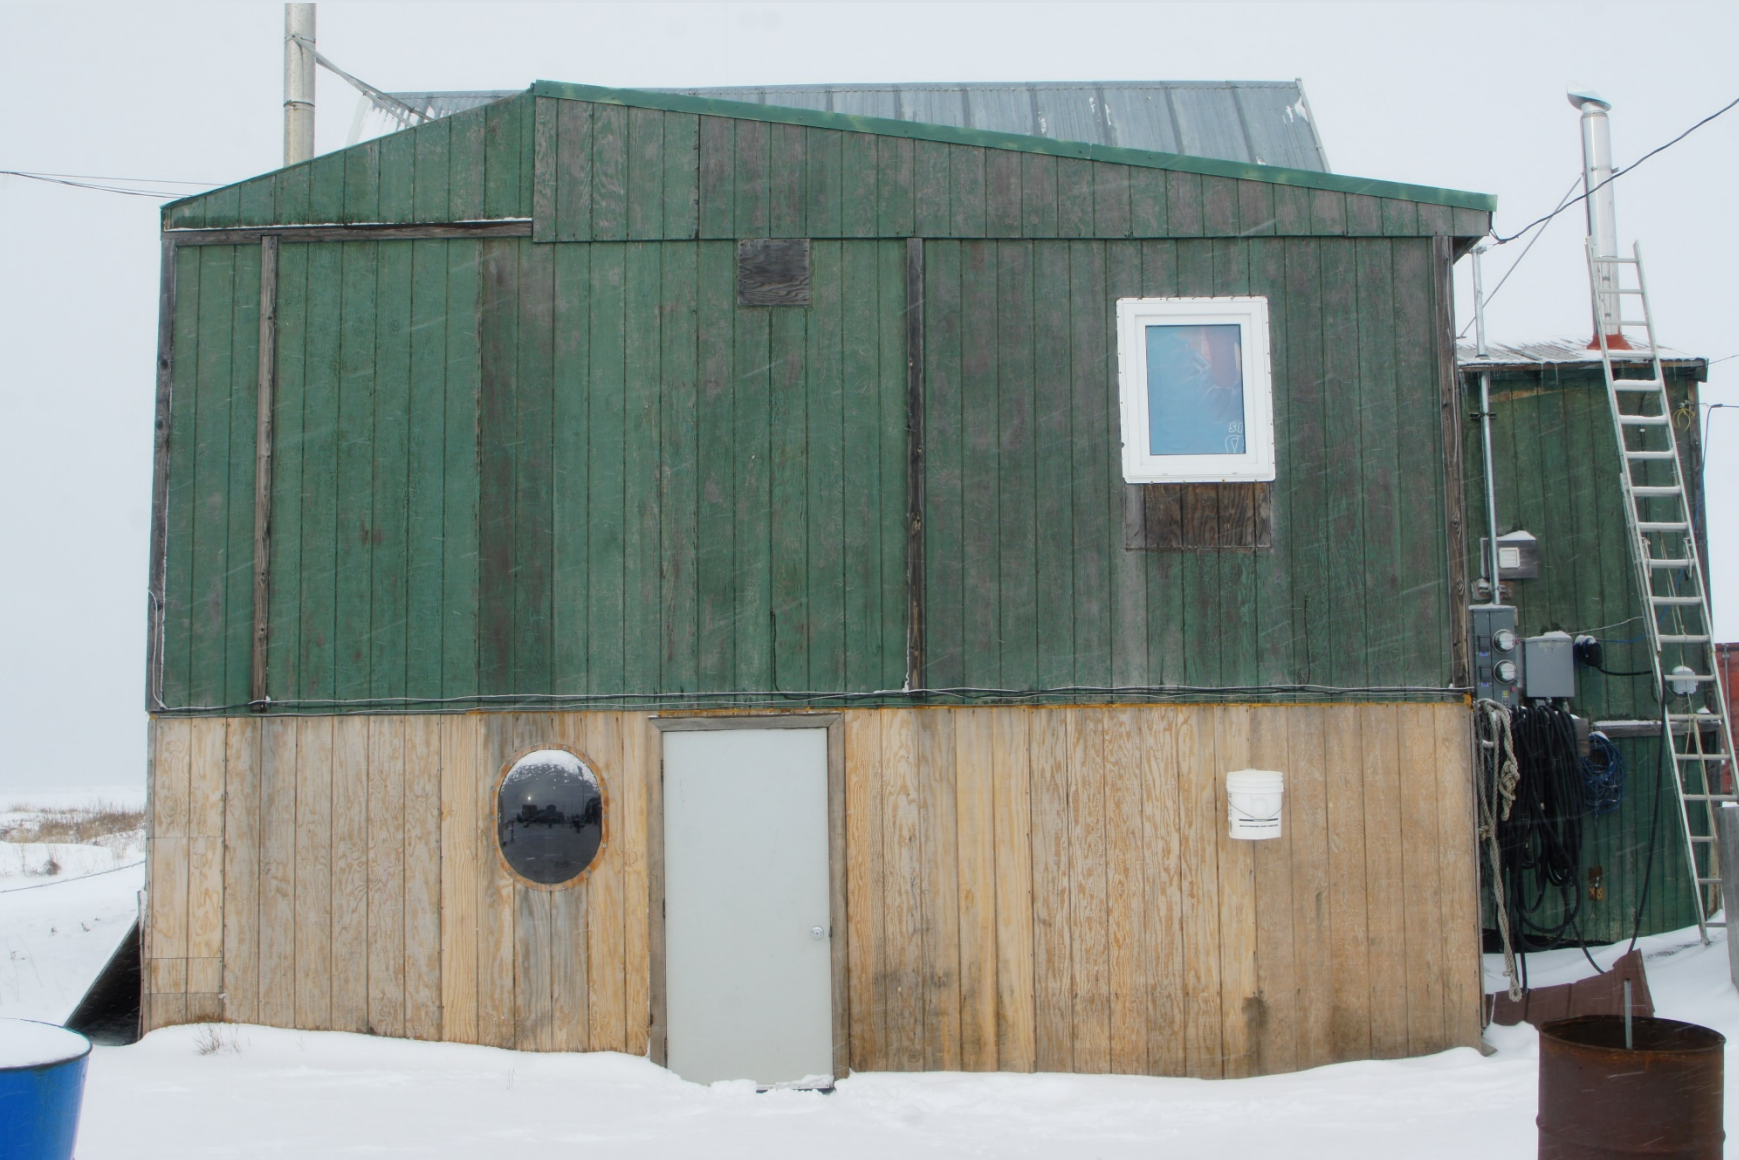
One story houses become two stories

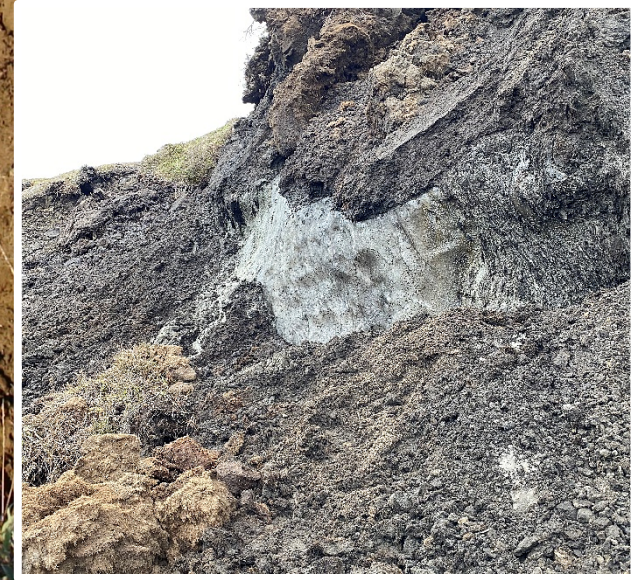
Ice cellar failure

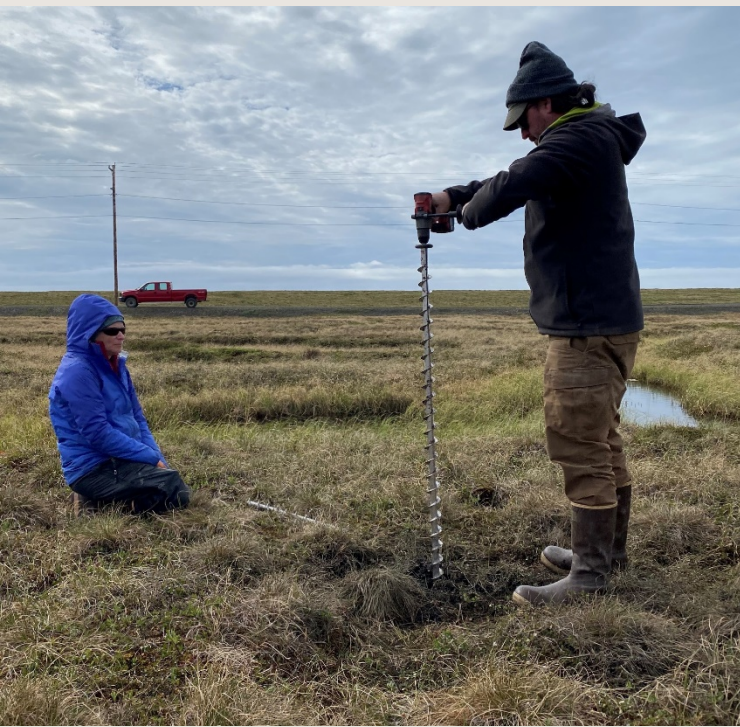
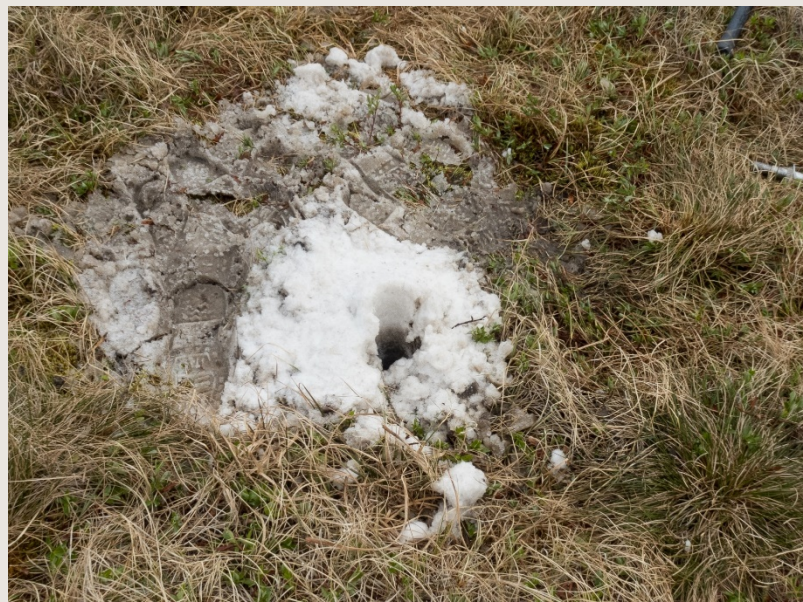
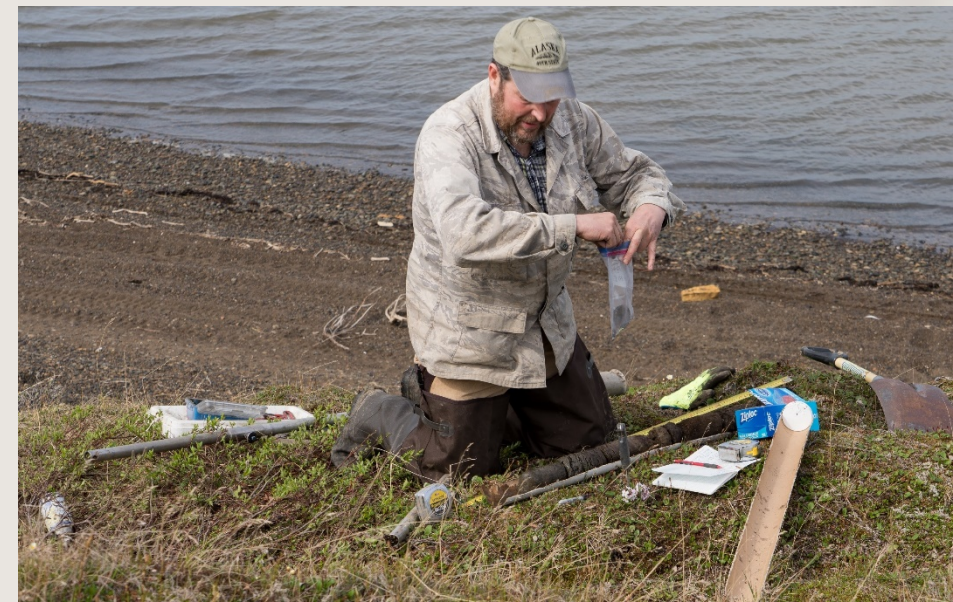
Permafrost coring and ice wedge
auguring to characterize ground
ice content and depth

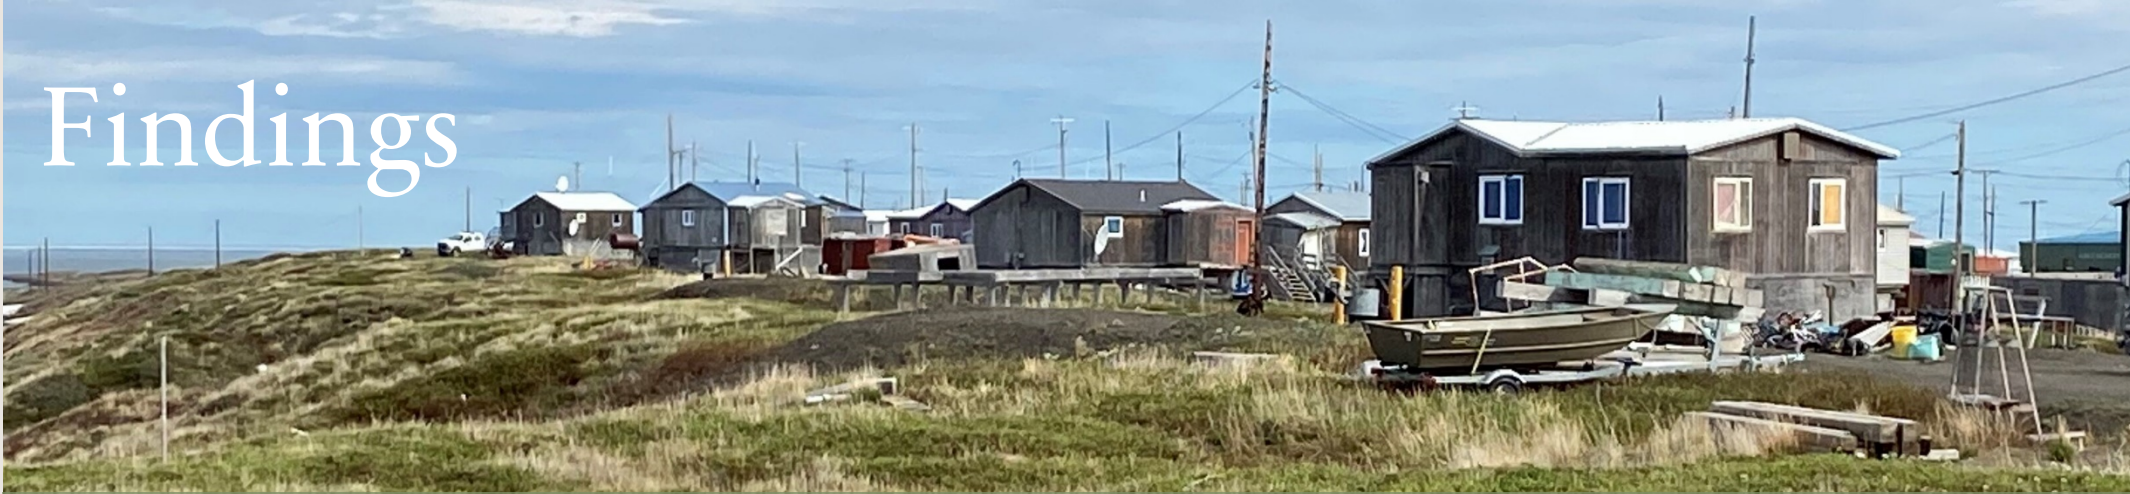
Most of the community is underlain by YEDOMA: a fine-grained, ice-rich permafrost. penetrated by large ice wedges. Ice wedges go to sea level and below (about 12 meters).

Wedge-content in yedoma may exceed 50% by volume. Thaw settlement may reach nearly 40% of the permafrost's thickness without taking ice-wedge volume into account.

Ground-ice content in the undeveloped area north of town is similar. Though the terrain is currently flatter, it would be vulnerable to thermokarst and thermal erosion if developed.

There is much less ice in the drained lake basin south and east of town. Ice wedges are much smaller and ice content usually not exceeding 15-20%. These low-lying basins are prone to flooding.

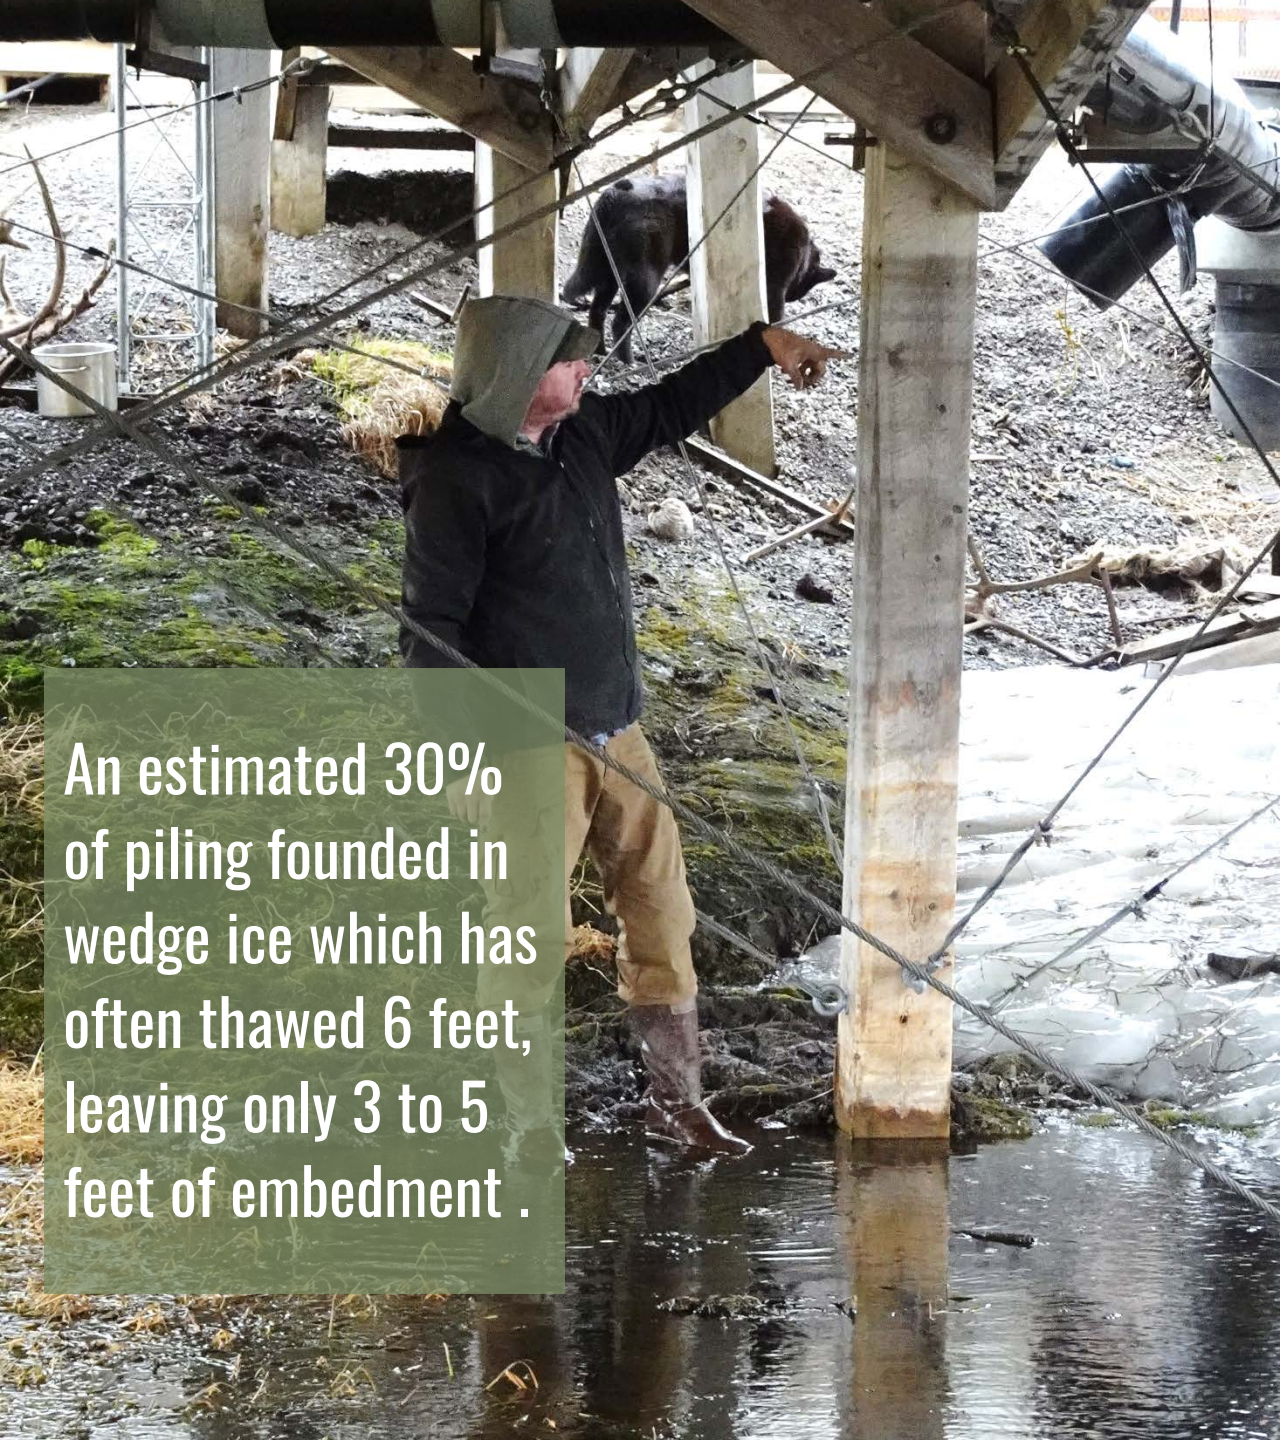
LEFT: Estimating the area of ice-rich permafrost (in red); RIGHT: The portion of the footprint of each home impacted by thermokarst.

An estimated 30% of piling founded in wedge ice which has often thawed 6 feet, leaving only 3 to 5 feet of embedment .
