# Assessing Micrometeorological and Geophysical Differences Related to the Built Environment in Utqiagvik, Alaska

Mirella Shaban<sup>(1)</sup>, MacKenzie Nelson<sup>(1)</sup>, Leena Cho<sup>(2)</sup>, Chan Charoonsophonsak<sup>(3)</sup>, Georgina Davis<sup>(3)</sup>, Thomas Douglas<sup>(4)</sup>, Tobias Gerken<sup>(5)</sup>, Claire G Griffin<sup>(1)</sup>, Matthew G Jull<sup>(2)</sup>, Luis Felipe Rosado Murillo<sup>(6)</sup>, Lars Nelson<sup>(7)</sup>, Caitlin D Wylie<sup>(8)</sup>, Howard E. Epstein<sup>(1)</sup>

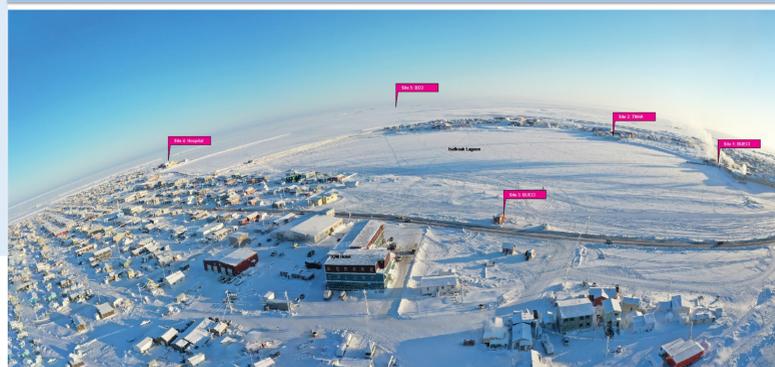
Figure 4. Drone image of the current station implementation locations in Utqiagvik. Image by M. Jull.

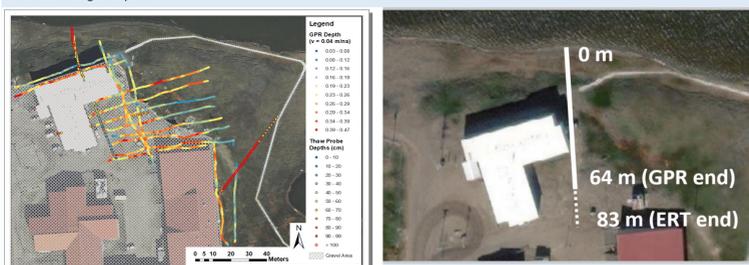
Figure 7.1. GPR/ERT/Thaw Probe tracts at TNHA, 2021.

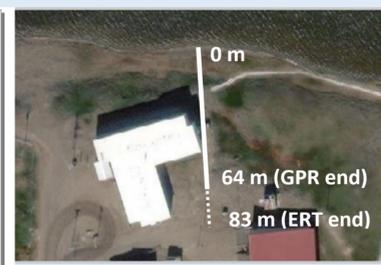
Figure 7.2. GPR & ERT tracts at TNHA, 2022.
